# Access Compliance Report

## Public Rights-of-Way

### (Curb Ramps)

Intersection ID: 4270		Main Street: N_TRYON_ST		Cross Street: SALOME_CHURCH_RD		Location:		SE									
ADA ID: 3802610D74D1		Ramp Type: Directional1		Initial Pass/Fail: Pass		Overall Compliance: No		Severity Score: 0									
Codes/Mitigation Info/Possible Solution				Field Measurements/Component Compliance													
<div>

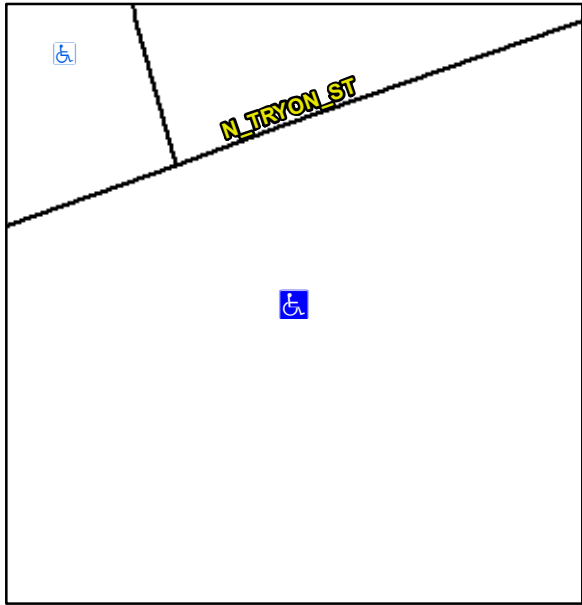
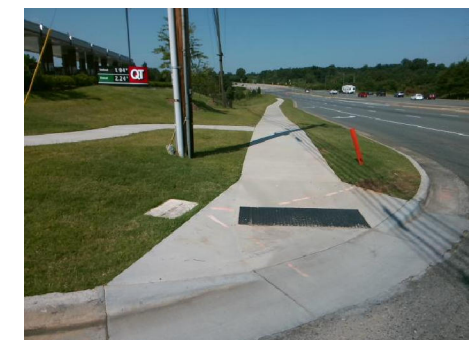
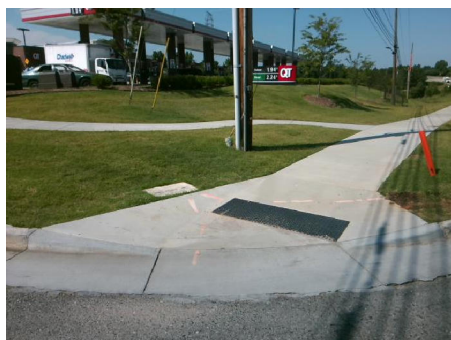
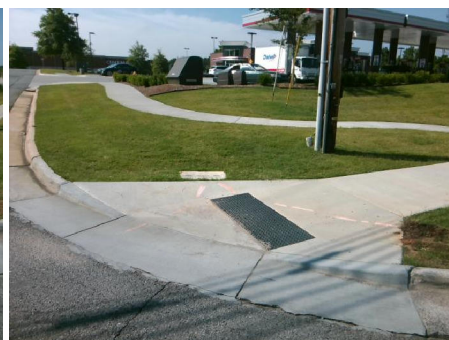
</div> <div>Street 1 NameSALOME CHURCH RD</div> <div>Stop Condition-Street 1StopSign</div> <div>Street 2 NameN/A</div> <div>Stop Condition-Street 2N/A</div>				Possible Solutions:		Compliance		Description		Data		Compliance		Description		Data	
				Remove & Replace Gutter.		N/A		Ramp Length (in)		73.0		Yes		Grade Break?		Yes	
						Yes		Ramp Width (in)		66.0		Yes		Grade Break Slope (%)		0.0	
						Yes		Ramp Slope (%)		6.7		Yes		Grade Break XSlope (%)		1.1	
						Yes		Ramp XSlope (%)		0.4							
						N/A		Flare Type LT		N/A		N/A		Flare Type RT		N/A	
						N/A		Flare Slope LT (%)		14.3		N/A		Flare Slope RT (%)		4.9

N/A		Flare Traversable LT?		No		N/A		Flare Traversable RT?		No	
						Yes		Landing Length (in)		60.0		Yes		DWS Provided?		Yes	
						Yes		Landing Width (in)		72.0		Yes		DWS Contrast?		Yes	
		Yes		Landing Slope (%)		2.0		Yes		DWS Length (in)		25.0					
		Yes		Landing X Slope (%)		0.2		Yes		DWS Full Width?		Yes					
		N/A		Landing Curb? (Y/N)		N/A		Yes		DWS Offset LT (in)		52.0					
		N/A		Shared Landing?		Yes		Yes		DWS Offset RT (in)		0.0					
		No		Gutter Ponding?		Yes		Yes		Gutter Slope (%)		1.7					
		Yes		Gutter Lip Ht (in)		0.0		No		Gutter X Slope (%)		3.6					
		N/A		Painted X Walk1?		No				Road Slope (%)		6.4					
				X Walk 1 Direction		To E				Road X Slope (%)		3.6					
				X Walk 1 Width (in)		N/A				Clear Space?		Yes					
				X Walk 1 Slope (%)		6.4		N/A		Clear Space to XWalk (in)		N/A					
				X Walk 1 X Slope (%)		3.6		Yes		Storm Grate/Utility Hazard?		No					
		N/A		Ramp inside XWalk1?		N/A				Storm Grate/Utility Type
