# Access Compliance Report

## Public Rights-of-Way

### (Curb Ramps)

| Intersection ID: 24623 | Main Street: CARMEL_RD | Cross Street: WINDWOOD_CR | Location: W |

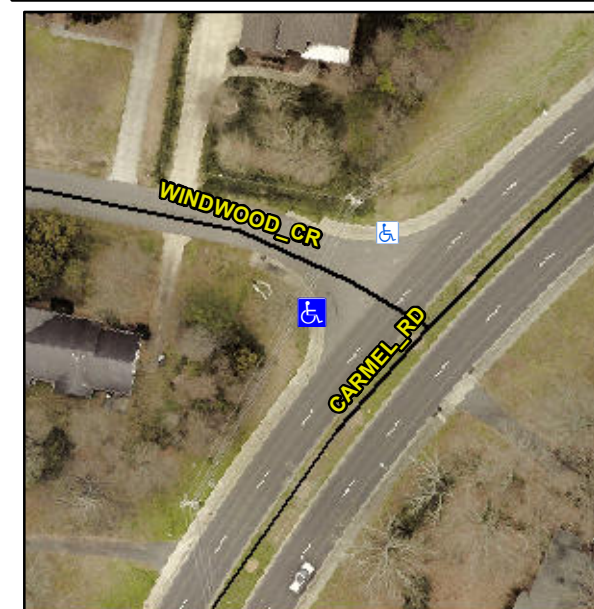
| ADA ID: 3843C1927D35 | Ramp Type: PerpDiag | Initial Pass/Fail: Fail | Overall Compliance: No |
| Severity Score: 22.5 | | | |

**Not Found, R304.5.1, R304.2.2, R304.5.3**

| Compliance | Description | Data | Compliance | Description | Data |
|---|---|---|---|---|---|
| N/A | Ramp Length (in) | 60.0 | No | Ramp Slope (%) | 9.2 |
| No | Ramp Width (in) | 45.0 | No | Ramp XSlope (%) | 3.6 |

**Remove & Replace Curb Ramp With Two New Directional Ramps or Equivalent.**
