# Access Compliance Report

## Public Rights-of-Way

### (Curb Ramps)

Intersection ID: 50747	Main Street: MONTELENA_DR	Cross Street: ARTESA_CT	Location:	NE
ADA ID: 3877174BC4FA	Ramp Type: Perp	Initial Pass/Fail: Fail	Overall Compliance: No	Severity Score: 8.75

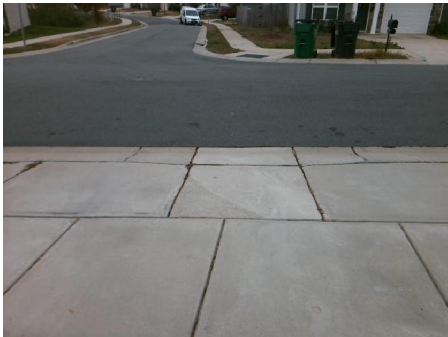
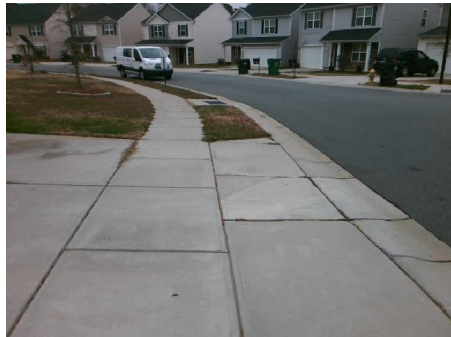
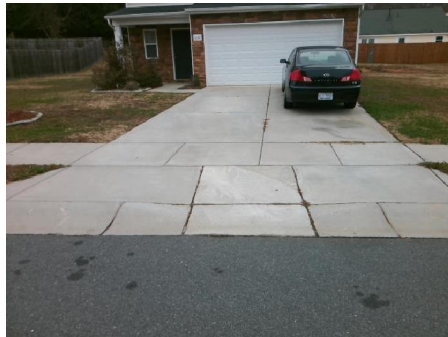
Possible Solutions:		<b>Compliance</b>	<b>Description</b>	<b>Data</b>
	<b>Remove &amp; Replace Entire Ramp.</b>		<b>Yes</b>	Ramp Length (in)	5.8
			<b>No</b>	Ramp Width (in)	0.2
			<b>N/A</b>	Flare Type LT	N/A
			<b>N/A</b>	Flare Slope LT (%)	N/A
			<b>N/A</b>	Flare Traversable LT?	N/A
			<b>N/A</b>	Landing Length (in)	N/A
			<b>N/A</b>	Landing Width (in)	N/A
			<b>N/A</b>	Landing Slope (%)	N/A
			<b>N/A</b>	Landing X Slope (%)	N/A
<p>Surveyor Notes:</p> <p><b>N/A</b></p> <p>PROW/ADA:</p> <p><b>Not Found, R304.5.1</b></p>			<b>N/A</b>	Flare Type RT	N/A
			<b>N/A</b>	Flare Slope RT (%)	N/A
			<b>N/A</b>	Flare Traversable RT?	N/A
			<b>N/A</b>	DWS Provided?	N/A
			<b>N/A</b>	DWS Contrast?	N/A
			<b>N/A</b>	DWS Length (in)	N/A
			<b>N/A</b>	DWS Full Width?	N/A
			<b>N/A</b>	DWS Offset (in)	N/A
			<b>N/A</b>	Shared Landing?	N/A

<b>N/A</b>	Gutter Ponding?	N/A
			<b>N/A</b>	Gutter Lip Ht (in)	N/A
			<b>N/A</b>	Painted X Walk1?	N/A
			<b>No</b>	Painted X Walk2?	N/A
			<b>To W</b>	X Walk 1 Direction	N/A
			<b>N/A</b>	X Walk 1 Width (in)	N/A
			<b>3.3</b>	X Walk 1 Slope (%)	N/A
			<b>2.6</b>	X Walk 1 X Slope (%)	N/A
			<b>N/A</b>	Ramp inside XWalk1?	N/A
			<b>N/A</b>	Ramp inside XWalk2?	N/A
			<b>N/A</b>	Road Slope (%)	N/A
			<b>N/A</b>	Road X Slope (%)	N/A
			<b>N/A</b>	Any Obstructions?	N/A
			<b>N/A</b>	Obstruction Type	N/A
			<b>N/A</b>	Clear Space?	N/A
			<b>N/A</b>	Clear Space to XWalk (in)	N/A
			<b>N/A</b>	Storm Grate/Utility Hazard?	N/A
			<b>N/A</b>	Storm Grate/Utility Type	N/A
			<b>N/A</b>	Surface Condition? (G/P)	Good
			<b>Yes</b>

Total Cost: \$ 1850.00
