Access Compliance Report

Public Rights-of-Way

(Curb Ramps)

Intersection ID: 25287	Main Street: CEDAR_POINT_LN	Cross Street: JOHNSTON_RD	Location: SW
ADA ID: 38B1E429A6DF	Ramp Type: Perp	Initial Pass/Fail: Fail	Overall Compliance: No
Severity Score: 12.5			
Codes/Mitigation Info/Possible Solution		Field Measurements/Component Compliance

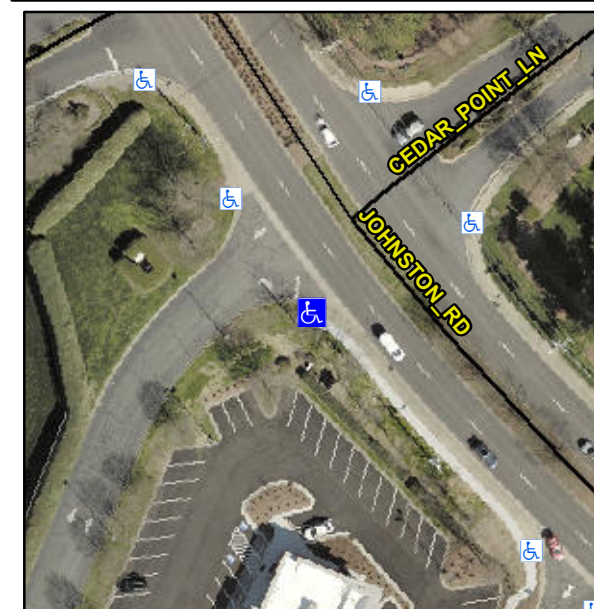
Compliance	Description	Data	Compliance	Description	Data
N/A	Ramp Length (in)	59.0	No	Ramp Slope (%)	8.8
Yes	Ramp Width (in)	48.0	Yes	Ramp XSlope (%)	1.2
N/A	Flare Type LT	N/A	N/A	Flare Type RT	N/A
N/A	Flare Slope LT (%)	N/A	N/A	Flare Slope RT (%)	N/A
N/A	Flare Traversable LT?	N/A	N/A	Flare Traversable RT?	N/A
N/A	Landing Length (in)	N/A	N/A	DWS Provided?	N/A
N/A	Landing Width (in)	N/A	N/A	DWS Contrast?	N/A
N/A	Landing Slope (%)	N/A	N/A	DWS Length (in)	N/A
N/A	Landing X Slope (%)	N/A	N/A	DWS Full Width?	N/A
N/A	Landing Curb? (Y/N)	N/A	N/A	DWS Offset (in)	N/A
N/A	Shared Landing?	N/A			
N/A	Gutter Ponding?	N/A	N/A	Gutter Slope (%)	N/A
N/A	Gutter Lip Ht (in)	N/A	N/A	Gutter X Slope (%)	N/A
N/A	Painted X Walk1?	No	N/A	Painted X Walk2?	N/A
	X Walk 1 Direction	To NW		X Walk 2 Direction	N/A
N/A	X Walk 1 Width (in)	N/A	N/A	X Walk 2 Width (in)	N/A
	X Walk 1 Slope (%)	0.2		X Walk 2 Slope (%)	N/A
	X Walk 1 X Slope (%)	1.8		X Walk 2 X Slope (%)	N/A

Possible Solutions:

Remove & Replace Entire Ramp.
