Intersection ID: 29432	Main Street: MIRTH_LN	Cross Street: PALESTRINA_RD	Location:	SW
ADA ID: 3959A2CA0D96	Ramp Type: Perp	Initial Pass/Fail: Fail	Overall Compliance: No	Severity Score: 21.25

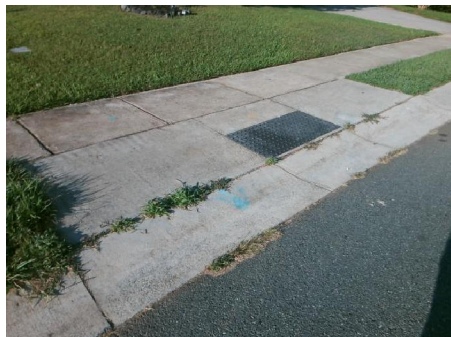
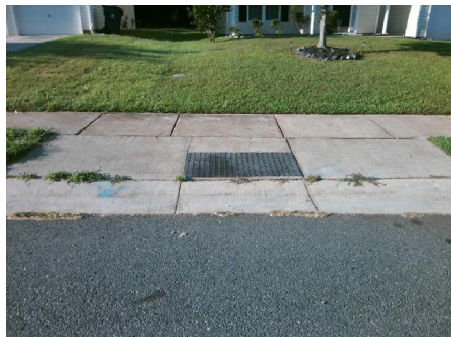
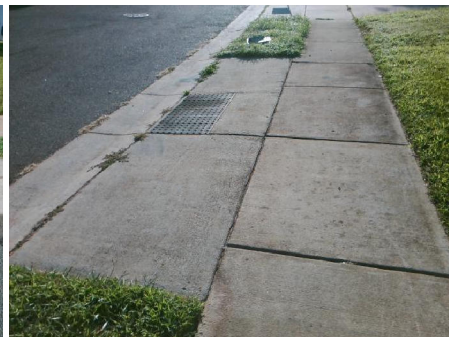
**Not Found, R304.5.1, R304.2.2**

Possible Solutions:			Compliance	Description	Data	Compliance	Description	Data		
<b>Remove &amp; Replace Entire Ramp.</b>			N/A	Ramp Length (in)	47.0	No	Ramp Slope (%)	9.0		
			No	Ramp Width (in)	47.5	Yes	Ramp XSlope (%)	1.4		
			N/A	Flare Type LT	N/A	N/A	Flare Type RT	N/A		
			N/A	Flare Slope LT (%)	N/A	N/A	Flare Slope RT (%)	N/A		
			N/A	Flare Traversable LT?	N/A	N/A	Flare Traversable RT?	N/A		
			N/A	Landing Length (in)	N/A	N/A	DWS Provided?	N/A		
			N/A	Landing Width (in)	N/A	N/A	DWS Contrast?	N/A		
			N/A	Landing Slope (%)	N/A	N/A	DWS Length (in)	N/A		
			N/A	Landing X Slope (%)	N/A	N/A	DWS Full Width?	N/A		
			N/A	Landing Curb? (Y/N)	N/A	N/A	DWS Offset (in)	N/A		
Surveyor Notes: <b>N/A</b>			N/A	Shared Landing?	N/A					
			N/A	Gutter Ponding?	N/A	N/A	Gutter Slope (%)	N/A		
			N/A	Gutter Lip Ht (in)	N/A	N/A	Gutter X Slope (%)	N/A		
			N/A	Painted X Walk1?	No	N/A	Painted X Walk2?	N/A		
				X Walk 1 Direction	To N		X Walk 2 Direction	N/A

### Remove & Replace Entire Ramp.
