# Access Compliance Report

## Public Rights-of-Way (Curb Ramps)

| Intersection ID: 53965 | Main Street: MAGNOLIA_LILY_AV | Cross Street: SPRING_SPRUCE_LN | Location: NW |
| ADA ID: 396E6491F62C | Ramp Type: Perp | Initial Pass/Fail: Pass | Overall Compliance: No |

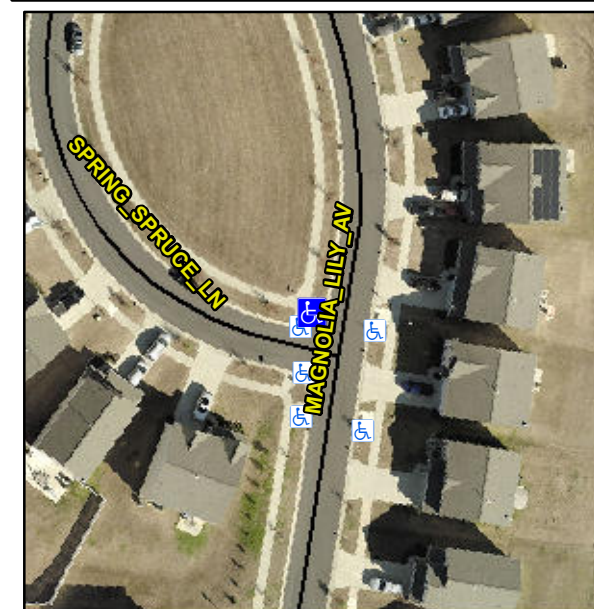
**Not Found, R304.5.3, R304.2.2-Perp,  
R304.3.2-Para, R305.2, R302.7.2,  
R304.5.4**

| Compliance | Description | Data | Compliance | Description | Data |
|---|---|---|---|---|---|
| Yes | Ramp Width (in) | 48.0 | No | Ramp XSlope (%) | 3.0 |
| No | Landing Slope (%) | 2.7 | Yes | DWS Length (in) | 24.0 |
| N/A | Landing Curb? (Y/N) | No | No | DWS Offset (in) | 3.0 |
| Yes | Gutter Ponding? | No | No | Gutter Slope (%) | 6.1 |
| No | Gutter Lip Ht (in) | 0.8 | Yes | Gutter X Slope (%) | 1.9 |

**Remove & Replace Entire Ramp.  
Remove & Replace Gutter.**
