# Access Compliance Report

## Public Rights-of-Way

### (Curb Ramps)

Intersection ID: 15639	Main Street: EASTOVER_RD	Cross Street: HEMPSTEAD_PL	Location: SE
ADA ID: 39B629CA5734	Ramp Type: PerpDiag	Initial Pass/Fail: Fail	Overall Compliance: No
Codes/Mitigation Info/Possible Solution		Field Measurements/Component Compliance	
Severity Score: 50

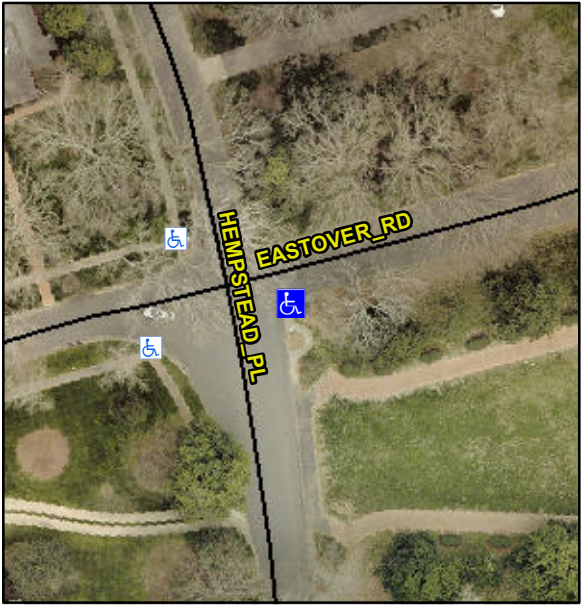
Possible Solutions:		Compliance	Description	Data	Compliance	Description	Data
	Remove & Replace Curb Ramp With Two New Directional Ramps or Equivalent.		N/A	Ramp Length (in)	52.0	No	Ramp Slope (%)	15.5
<p>Surveyor Notes:</p> <p>N/A</p> <p>PROW/ADA:</p> <p>R304.2.2, R304.5.3</p>			Yes	Ramp Width (in)	48.0	No	Ramp XSlope (%)	7.8
			N/A	Flare Type LT	N/A	N/A	Flare Type RT	N/A
<p>Street 1 Name</p> <p>Stop Condition-Street 2</p> <p>Street 2 Name</p> <p>Stop Condition-Street 1</p>			N/A	Flare Slope LT (%)	N/A	N/A	Flare Slope RT (%)	N/A
			N/A	Flare Traversable LT?	N/A	N/A	Flare Traversable RT?	N/A
<p>Total Cost:</p> <p>\$ 3200.00</p>			N/A	Landing Length (in)	N/A	N/A	DWS Provided?	N/A
			N/A	Landing Width (in)	N/A	N/A	DWS Contrast?	N/A
			N/A	Landing Slope (%)	N/A	N/A	DWS Length (in)	N/A
			N/A	Landing X Slope (%)	N/A	N/A	DWS Full Width?	N/A
			N/A	Landing Curb? (Y/N)	N/A	N/A	DWS Offset (in)	N/A
			N/A	Shared Landing?	N/A
