Access Compliance Report Public Rights-of-Way (Curb Ramps)

Intersection ID: 8522 Main Street: MARBLE_ST Cross Street: WILLARD_ST Location: NE

ADA ID: 3A1BE1839151 Ramp Type: Directional1 Initial Pass/Fail: Fail Overall Compliance: No Severity Score: 12.5

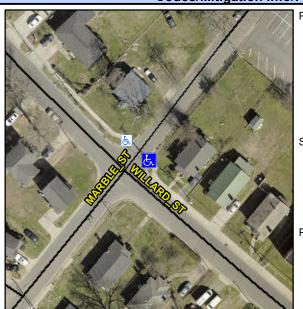
PROW/ADA:
R304.2.2

| Fleid Measurements/Component Compilance | | | | | |
|---|---|---|---|---|---|
| No | Ramp Slope (%) | 8.9 | N/A | Grade Break XSlope (%) | 0.0 |

Remove & Replace Entire Ramp.
