Access Compliance Report Public Rights-of-Way (Curb Ramps)

Intersection ID: 10025598Main Street: E_WOODLAWN_RDCross Street: N/ALocation:SWADA ID: 3A23EFFA24F1Ramp Type: ParaInitial Pass/Fail: FailOverall Compliance: NoSeverity Score: 13.75

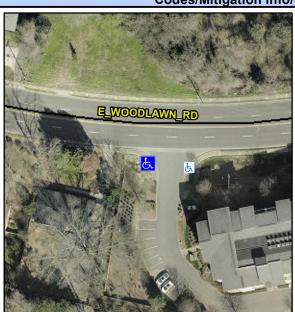
Field Measurements/Component Compliance						
Comp	liance Description	Data	Comp	liance Description	Data	
N/A	Ramp Length LT (in)	62.0	N/A	Ramp Length RT (in)	70.0	
Yes	Ramp Width LT (in)	59.0	Yes	Ramp Width RT (in)	59.0	
No	Ramp Slope LT (%)	8.5	Yes	Ramp Slope RT (%)	5.1	
No	Ramp XSlope LT (%)	2.4	No	Ramp XSlope RT (%)	3.5	
N/A	Landing Length (in)	N/A	N/A	DWS Provided?	N/A	
N/A	Landing Width (in)	N/A	N/A	DWS Contrast?	N/A	
N/A	Landing Slope (%)	N/A	N/A	DWS Length (in)	N/A	
N/A	Landing X Slope (%)	N/A	N/A	DWS Full Width?	N/A	
N/A	Landing Curb? (Y/N)	N/A	N/A	DWS Offset (in)	N/A	
N/A	Shared Landing?	N/A				
N/A	Gutter Ponding?	N/A	N/A	Gutter Slope (%)	N/A	
N/A	Gutter Lip Ht (in)	N/A	N/A	Gutter X Slope (%)	N/A	
N/A	Painted X Walk1?	No	N/A	Painted X Walk2?	N/A	
	X Walk 1 Direction	To E		X Walk 2 Direction	N/A	
N/A	X Walk 1 Width (in)	N/A	N/A	X Walk 2 Width (in)	N/A	
	X Walk 1 Slope (%)	6.7		X Walk 2 Slope (%)	N/A

X Walk 1 X Slope (%)	3.7		X Walk 2 X Slope (%)	N/A	
N/A	Ramp inside XWalk1?	N/A	N/A	Ramp inside XWalk2?	N/A	
	Road Slope (%)	N/A	N/A	Clear Space?	N/A	
	Road X Slope (%)	N/A	N/A	Clear Space to XWalk (in)	N/A	
N/A	Any Obstructions?	N/A	N/A	Storm Grate/Utility Hazard?	N/A	
	Obstruction Type			Storm Grate/Utility Type		
		N/A			N/A	
			Yes	Surface Condition? (G/P)	Good	
			N/A	Curb Slope (%)	18.4

1 099ibic Ocidiioii	
Possible Solutions:	С
Remove & Replace Entire Ramp.	N
·	Y
	N
	N
	N
	N
Surveyor Notes:	N
N/A	N
	N
	N
	N
PROW/ADA:	N.
R304.3.2, R304.5.3	N
	N
