# Access Compliance Report

## Public Rights-of-Way

| Intersection ID: 43521 | Main Street: MORNING_BREEZE_LN | Cross Street: MISTRAL_WY | Location: | N |
| ADA ID: 3A266AE0920F | Ramp Type: Perp | Initial Pass/Fail: Fail | Overall Compliance: No | Severity Score: 12.5 |

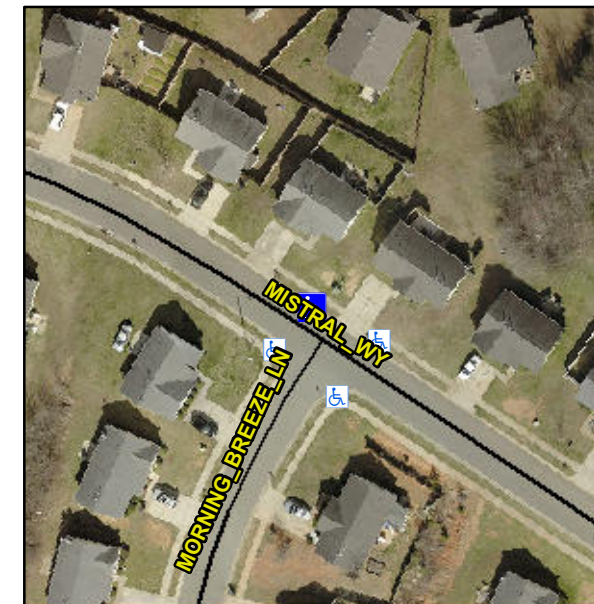
**Not Found, R304.5.3**

| Compliance | Description | Data | Compliance | Description | Data |
|---|---|---|---|---|---|
| Yes | Ramp Width (in) | 58.0 | No | Ramp XSlope (%) | 6.3 |

**Remove & Replace Entire Ramp.**

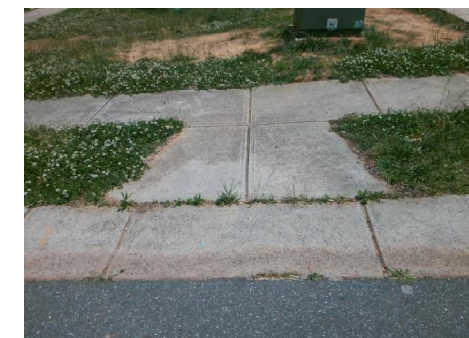
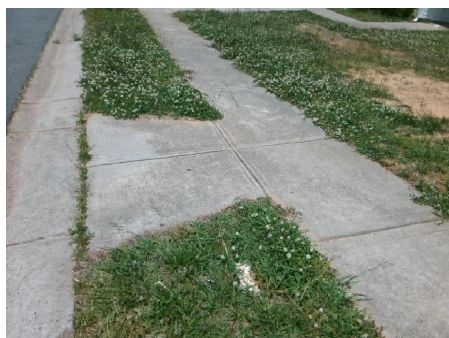
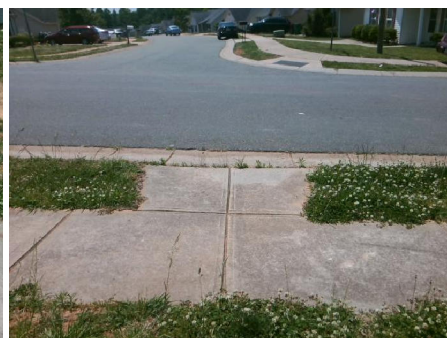
| Compliance | Description | Data | Compliance | Description | Data |
|---|---|---|---|---|---|
| | X Walk 1 X Slope (%) | 6.4 | | X Walk 2 X Slope (%) | N/A |
