Access Compliance Report Public Rights-of-Way (Curb Ramps)

Intersection ID: 46817Main Street: ARBOR_VISTA_DRCross Street: HOLM_OAK_PLLocation: NWADA ID: 3AA0BD43BBEBRamp Type: PerpDiagInitial Pass/Fail: Fail Overall Compliance: No Severity Score: 30

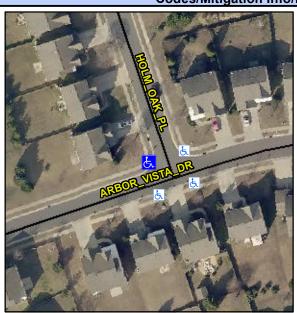
Fleid Measurements/Component Compilance						
Compliance Description		Data	Comp	Compliance Description		
N/A	Ramp Length (in)	43.5	No	Ramp Slope (%)	10.2	
No	Ramp Width (in)	32.5	Yes	Ramp XSlope (%)	0.6	
N/A	Flare Type LT	N/A	N/A	Flare Type RT	N/A	
N/A	Flare Slope LT (%)	N/A	N/A	Flare Slope RT (%)	N/A	
N/A	Flare Traversable LT?	N/A	N/A	Flare Traversable RT?	N/A	
N/A	Landing Length (in)	N/A	N/A	DWS Provided?	N/A	
N/A	Landing Width (in)	N/A	N/A	DWS Contrast?	N/A	
N/A	Landing Slope (%)	N/A	N/A	DWS Length (in)	N/A	
N/A	Landing X Slope (%)	N/A	N/A	DWS Full Width?	N/A	
N/A	Landing Curb? (Y/N)	N/A	N/A	DWS Offset (in)	N/A	
N/A	Shared Landing?	N/A				
N/A	Gutter Ponding?	N/A	N/A	Gutter Slope (%)	N/A	
N/A	Gutter Lip Ht (in)	N/A	N/A	Gutter X Slope (%)	N/A	
N/A	Painted X Walk1?	No	N/A	Painted X Walk2?	No	
	X Walk 1 Direction	To S		X Walk 2 Direction	ТоЕ	
N/A	X Walk 1 Width (in)	N/A	N/A	X Walk 2 Width (in)	N/A	
	X Walk 1 Slope (%)	2.6		X Walk 2 Slope (%)	0.1

X Walk 1 X Slope (%)	0.3		X Walk 2 X Slope (%)	2.3	
N/A	Ramp inside XWalk1?	N/A	N/A	Ramp inside XWalk2?	N/A	
	Road Slope (%)	1.6	N/A	Clear Space?	N/A	
	Road X Slope (%)	2.4	N/A	Clear Space to XWalk (in)	N/A	
N/A	Any Obstructions?	N/A	N/A	Storm Grate/Utility Hazard?	N/A	
	Obstruction Type			Storm Grate/Utility Type		
		N/A			N/A	
			Yes	Surface Condition? (G/P)	Good

Possible Solution
Possible Solutions:
Remove & Replace Curb Ramp With Two New Directional Ramps or Equivalent.
Surveyor Notes:
N/A
PROW/ADA:
Not Found, R304.5.1, R304.2.2
