Access Compliance Report Public Rights-of-Way (Curb Ramps)

Intersection ID: 27397 Main Street: ELM_LN Cross Street: BALLANTYNE_COMMONS_PY Location: NW ADA ID: 3B8A634AFD25 Ramp Type: Perp Initial Pass/Fail: Fail **Overall Compliance: No** Severity Score: 21.25

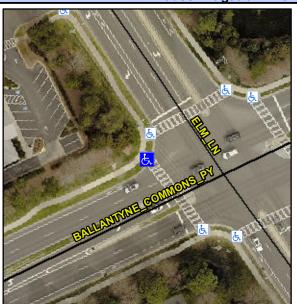
| Ossible Solution | |
|---|---|
| Not Found, R304.5.1, R304.2.2 | N |

| Field Measurements/Component Compliance | | | | | | | | |
|---|---|---|---|---|---|---|--|--|
| N/A | Ramp Length (in) | 80.0 | No | Ram | o Slope (%) | 8.4 | | |
| No | Ramp Width (in) | 42.0 | Yes | Ram | xSlope (%) | 2.0 | | |

| Ossible Solution | |
|---|---|
| Remove & Replace Entire Ramp. | |
