# Access Compliance Report

## Public Rights-of-Way

### (Curb Ramps)

Intersection ID: 11994	Main Street: BELVEDERE_AV	Cross Street: THE_PLAZA	Location: SW
ADA ID: 3BAA1A8F6548	Ramp Type: Perp	Initial Pass/Fail: Fail	Overall Compliance: No
			Severity Score: 33.75

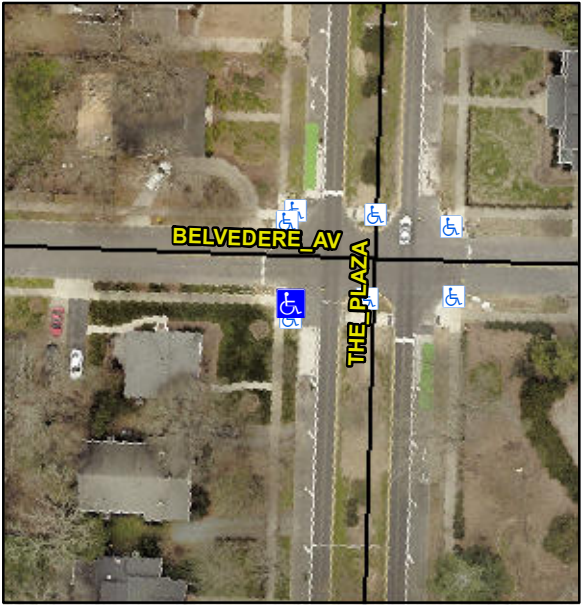
Possible Solutions:		<b>Compliance</b>	<b>Description</b>	<b>Data</b>
	Remove & Replace Entire Ramp.		N/A	Ramp Length (in)	42.0
			No	Ramp Width (in)	47.0
			N/A	Flare Type LT	N/A
			N/A	Flare Slope LT (%)	N/A
			N/A	Flare Traversable LT?	N/A
			N/A	Landing Length (in)	N/A
			N/A	Landing Width (in)	N/A
			N/A	Landing Slope (%)	N/A
			N/A	Landing X Slope (%)	N/A
<p>Surveyor Notes:</p> <p>N/A</p> <p>PROW/ADA:</p> <p>Not Found, R304.5.1, R304.2.2</p>			N/A	Flare Type RT	N/A
			N/A	Flare Slope RT (%)	N/A
			N/A	Flare Traversable RT?	N/A
			N/A	DWS Provided?	N/A
			N/A	DWS Contrast?	N/A
			N/A	DWS Length (in)	N/A
			N/A	DWS Full Width?	N/A
			N/A	DWS Offset (in)	N/A
			N/A	Shared Landing?	N/A
			N/A	Gutter Ponding?	Yes
			N/A	Gutter Lip Ht (in)	N/A
			N/A	Painted X Walk1?	Yes
				X Walk 1 Direction	To N
			N/A	X Walk 1 Width (in)	138.0

X Walk 1 Slope (%)	4.5
				X Walk 1 X Slope (%)	2.0
			N/A	Ramp inside XWalk1?	Yes
				Road Slope (%)	N/A
				Road X Slope (%)	N/A
			N/A	Any Obstructions?	N/A
				Obstruction Type	
Total Cost:		\$ 1850.00			
			N/A		N/A
			Yes	Surface Condition? (G/P)	Good
