Access Compliance Report

Public Rights-of-Way

(Curb Ramps)

| Intersection ID: 28105 | Main Street: ELLINGTON PARK DR | Cross Street: OLIVIA LN | Location: NE |

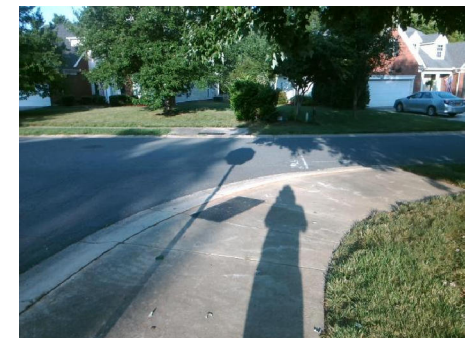
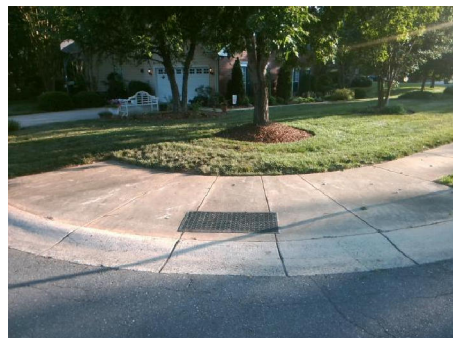
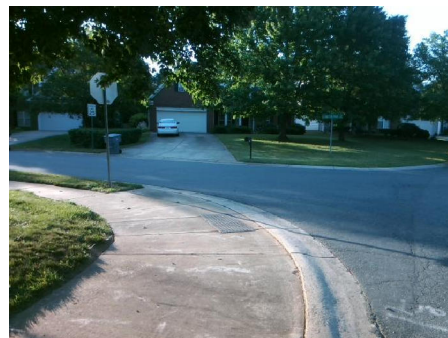
| ADA ID: 3C110C3270B5 | Ramp Type: BlendTrans2 | Initial Pass/Fail: Fail | Overall Compliance: No |

Not Found, R304.5.1

| Compliance | Description | Data | Compliance | Description | Data |
|---|---|---|---|---|---|
| No | Ramp Width (in) | 31.0 | Yes | BlendTrans XSlope (%) | 0.8 |
| | | | No | Curb Slope (%) | 14.9 |

Remove & Replace Curb Ramp With Two New Directional Ramps or Equivalent.
