# Access Compliance Report

## Public Rights-of-Way

### (Curb Ramps)

Intersection ID: 7027	Main Street: TALUS_TRACE_LN	Cross Street: BEGONIA_DR	Location:	E
ADA ID: 3C1A6F949AEF	Ramp Type: PerpDiag	Initial Pass/Fail: Fail	Overall Compliance: No	Severity Score: 8.75
Codes/Mitigation Info/Possible Solution		Field Measurements/Component Compliance

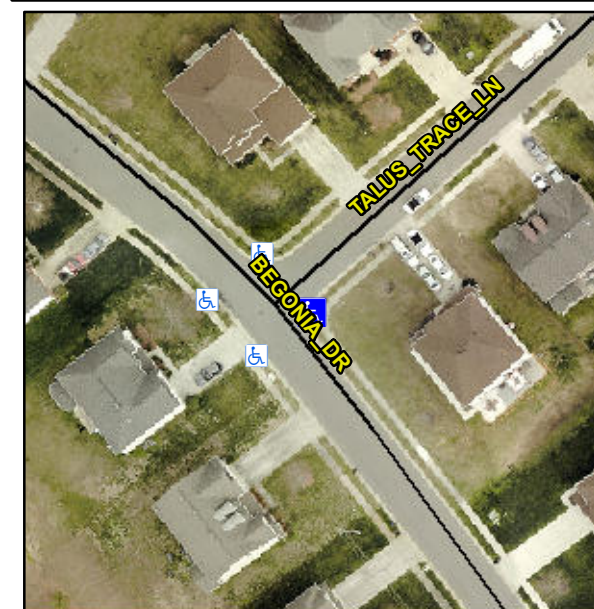
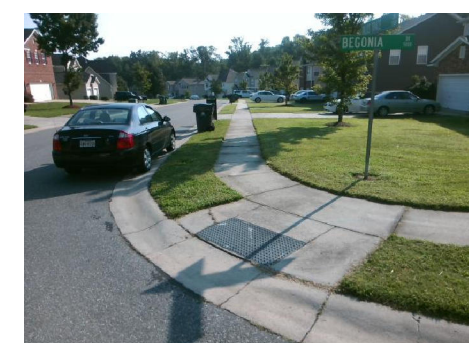
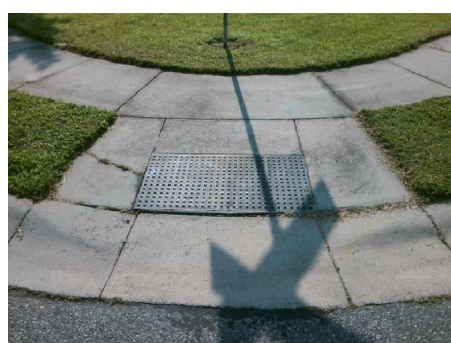
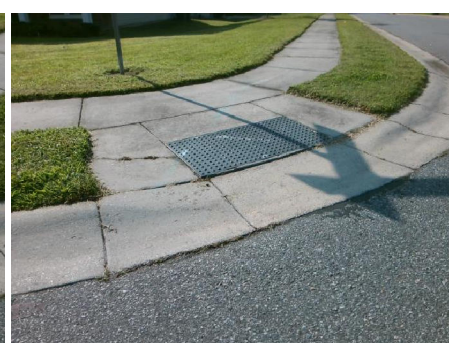
**Not Found, R304.5.1**

Compliance	Description	Data	Compliance	Description	Data
N/A	Ramp Length (in)	49.0	Yes	Ramp Slope (%)	6.1
No	Ramp Width (in)	47.0	Yes	Ramp XSlope (%)	1.2
N/A	Flare Type LT	N/A	N/A	Flare Type RT	N/A
N/A	Flare Slope LT (%)	N/A	N/A	Flare Slope RT (%)	N/A
N/A	Flare Traversable LT?	N/A	N/A	Flare Traversable RT?	N/A
N/A	Landing Length (in)	N/A	N/A	DWS Provided?	N/A
N/A	Landing Width (in)	N/A	N/A	DWS Contrast?	N/A
N/A	Landing Slope (%)	N/A	N/A	DWS Length (in)	N/A
N/A	Landing X Slope (%)	N/A	N/A	DWS Full Width?	N/A
N/A	Landing Curb? (Y/N)	N/A	N/A	DWS Offset (in)	N/A
N/A	Shared Landing?	N/A			
N/A	Gutter Ponding?	N/A	N/A	Gutter Slope (%)	N/A
N/A	Gutter Lip Ht (in)	N/A	N/A	Gutter X Slope (%)	N/A
N/A	Painted X Walk1?	No	N/A	Painted X Walk2?	No
	X Walk 1 Direction	To NW		X Walk 2 Direction	To SW
N/A	X Walk 1 Width (in)	N/A	N/A	X Walk 2 Width (in)	N/A
	X Walk 1 Slope (%)	2.9		X Walk 2 Slope (%)	2.4
	X Walk 1 X Slope (%)	3.0		X Walk 2 X Slope (%)	2.7

N/A	Ramp inside XWalk1?	N/A	N/A	Ramp inside XWalk2?	N/A
	Road Slope (%)	2.2	N/A	Clear Space?	N/A
	Road X Slope (%)	4.3	N/A	Clear Space to XWalk (in)	N/A
N/A	Any Obstructions?	N/A	N/A	Storm Grate/Utility Hazard?	N/A
	Obstruction Type			Storm Grate/Utility Type	
		N/A			N/A
			Yes	Surface Condition? (G/P)	Good

**Remove & Replace Curb Ramp With Two New Directional Ramps or Equivalent.**
