# Access Compliance Report

## Public Rights-of-Way

| Intersection ID: 30431 | Main Street: CEDAR_ROCK_DR | Cross Street: ELM_BEND_DR | Location: NE |
| ADA ID: 3CB0D8512A1C | Ramp Type: PerpDiag | Initial Pass/Fail: Fail | Overall Compliance: No |

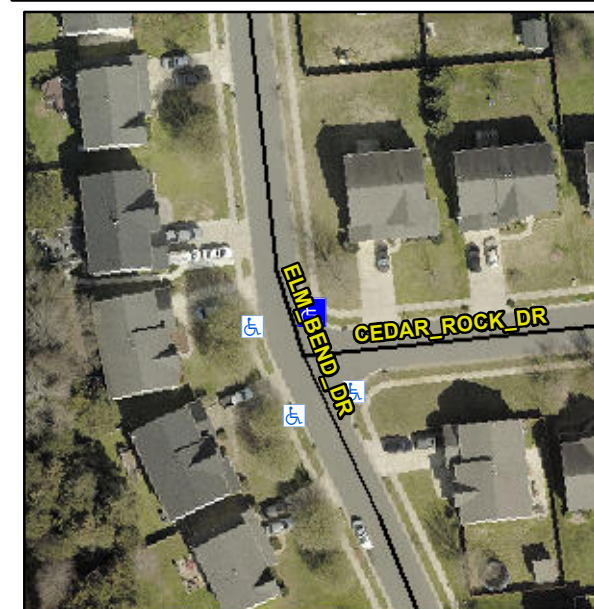
**R304.2.2, R304.5.3**

| Compliance | Description | Data | Compliance | Description | Data |
|---|---|---|---|---|---|
| N/A | Ramp Length (in) | 49.0 | No | Ramp Slope (%) | 8.9 |
| Yes | Ramp Width (in) | 48.0 | No | Ramp XSlope (%) | 2.7 |

**Remove & Replace Curb Ramp With Two New Directional Ramps or Equivalent.**
