# Access Compliance Report

## Public Rights-of-Way

### (Curb Ramps)

| Intersection ID: 7038 | Main Street: BROOKWOOD_RD | Cross Street: WOODWIND_ST | Location: SE |

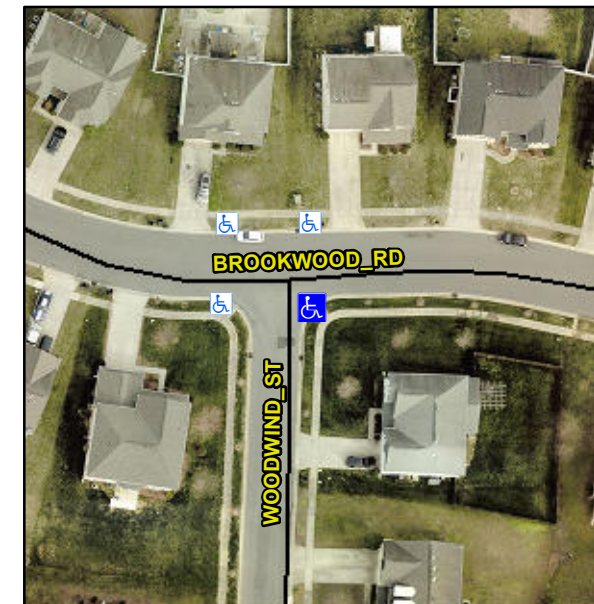
| ADA ID: 3D1EAAEE9DD4 | Ramp Type: BlendTrans1 | Initial Pass/Fail: Fail | Overall Compliance: No |

**CURB GAP 1.0**

**Not Found, R304.5.1**

| Compliance | Description | Data | Compliance | Description | Data |
|---|---|---|---|---|---|
| No | Ramp Width (in) | 47.0 | Yes | BlendTrans XSlope (%) | 1.3 |
| | | | No | Curb Slope (%) | 26.3 |

**Remove & Replace Curb Ramp With Two New Directional Ramps or Equivalent.**
