## **Access Compliance Report Public Rights-of-Way** (Curb Ramps)

Intersection ID: N/A Main Street: CENTRAL AV **Cross Street: TAMPLE LN** Location: NE Initial Pass/Fail: Fail **Overall Compliance: No ADA ID: 3D353813ADAA** Ramp Type: Combination2 Severity Score: 31.25

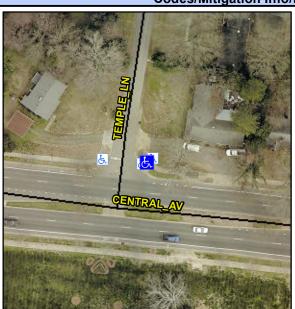
Street 1 Name StopSign Stop Condition-Street 1 **TEMPLE LN** Street 2 Name N/A Stop Condition-Street 2 N/A Possible Solutions: Compliance Description N/A Remove & Replace Entire Ramp. Yes Yes Yes N/A No Surveyor Notes: N/A N/A N/A N/A N/A N/A PROW/ADA: N/A Not Found, R304.5.1 N/A N/A N/A N/A N/A N/A
