Access Compliance Report

Public Rights-of-Way

(Curb Ramps)

Intersection ID: 28002	Main Street: COLONIAL_COUNTRY_LN	Cross Street: OLD_TAYPORT_PL	Location: E
ADA ID: 3D3591E52AB3	Ramp Type: PerpDiag	Initial Pass/Fail: Fail	Overall Compliance: No
Severity Score: 8.75			
Codes/Mitigation Info/Possible Solution		Field Measurements/Component Compliance

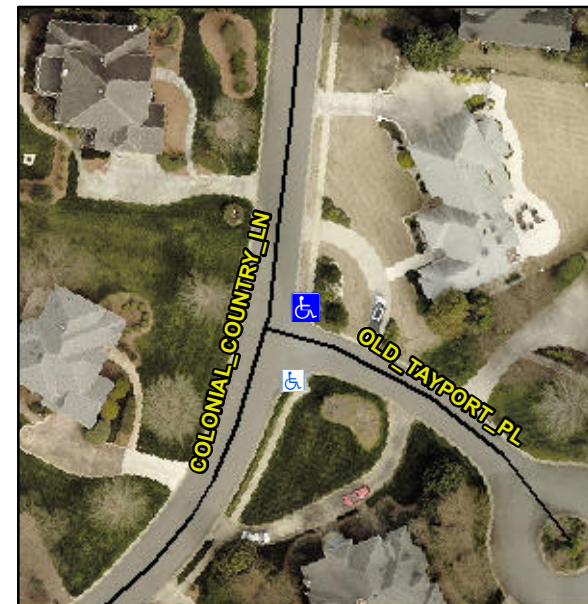
Not Found, R304.5.1

Compliance	Description	Data	Compliance	Description	Data
N/A	Ramp Length (in)	85.0	Yes	Ramp Slope (%)	7.0
No	Ramp Width (in)	40.5	Yes	Ramp XSlope (%)	0.5
N/A	Flare Type LT	N/A	N/A	Flare Type RT	N/A
N/A	Flare Slope LT (%)	N/A	N/A	Flare Slope RT (%)	N/A
N/A	Flare Traversable LT?	N/A	N/A	Flare Traversable RT?	N/A
N/A	Landing Length (in)	N/A	N/A	DWS Provided?	N/A
N/A	Landing Width (in)	N/A	N/A	DWS Contrast?	N/A
N/A	Landing Slope (%)	N/A	N/A	DWS Length (in)	N/A
N/A	Landing X Slope (%)	N/A	N/A	DWS Full Width?	N/A
N/A	Landing Curb? (Y/N)	N/A	N/A	DWS Offset (in)	N/A
N/A	Shared Landing?	N/A			
N/A	Gutter Ponding?	N/A	N/A	Gutter Slope (%)	N/A
N/A	Gutter Lip Ht (in)	N/A	N/A	Gutter X Slope (%)	N/A
N/A	Painted X Walk1?	No	N/A	Painted X Walk2?	No
	X Walk 1 Direction	To NW		X Walk 2 Direction	To SW
N/A	X Walk 1 Width (in)	N/A	N/A	X Walk 2 Width (in)	N/A
	X Walk 1 Slope (%)	3.4		X Walk 2 Slope (%)	3.0
	X Walk 1 X Slope (%)	1.6		X Walk 2 X Slope (%)	1.6

Remove & Replace Curb Ramp With Two New Directional Ramps or Equivalent.

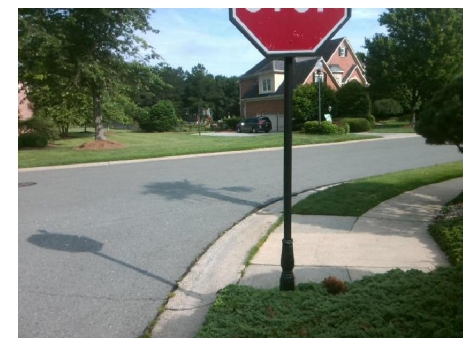
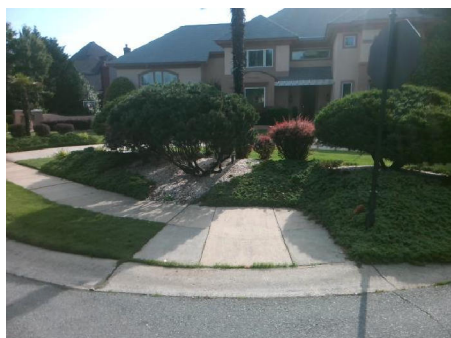
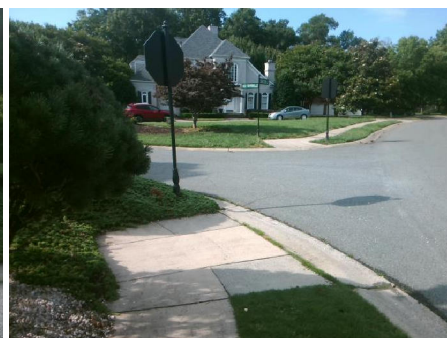
N/A	Ramp inside XWalk1?	N/A	N/A	Ramp inside XWalk2?	N/A
	Road Slope (%)	0.9	N/A	Clear Space?	N/A
	Road X Slope (%)	5.7	N/A	Clear Space to XWalk (in)	N/A
N/A	Any Obstructions?	N/A	N/A	Storm Grate/Utility Hazard?	N/A
	Obstruction Type			Storm Grate/Utility Type	
		N/A			N/A
		Yes		Surface Condition? (G/P)	Good
