Access Compliance Report

Public Rights-of-Way

(Curb Ramps)

Intersection ID: 50606	Main Street: DENBUR_DR	Cross Street: BENDING_BRANCH_RD	Location: W
ADA ID: 3D558DF8D840	Ramp Type: Perp	Initial Pass/Fail: Fail	Overall Compliance: No
Severity Score: 10			
Codes/Mitigation Info/Possible Solution		Field Measurements/Component Compliance

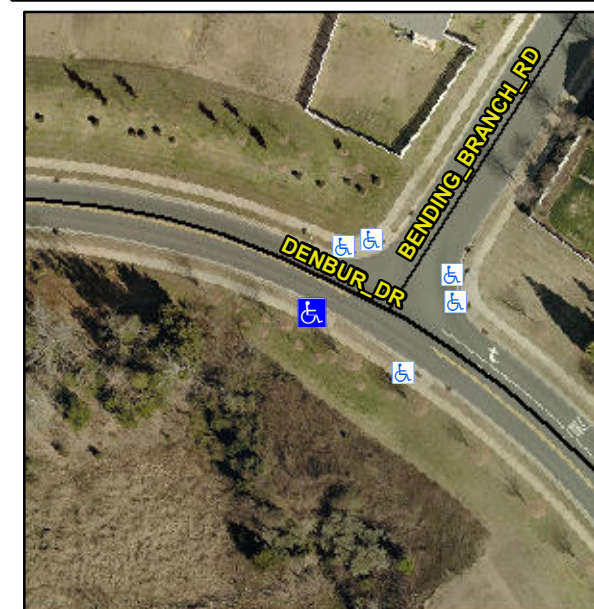
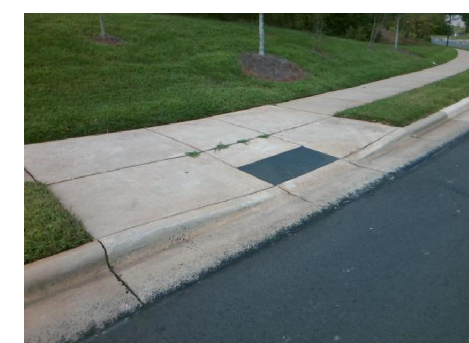
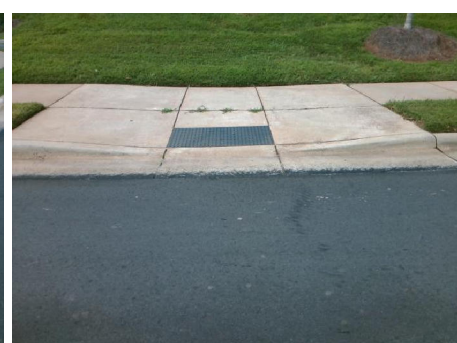
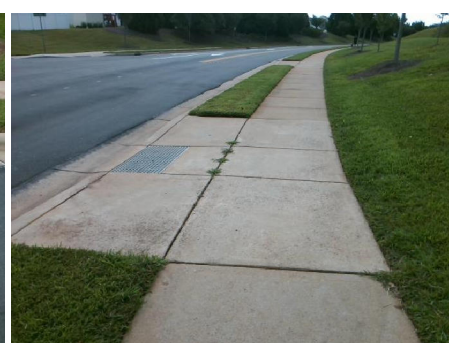
Not Found, R304.5.1

Compliance	Description	Data	Compliance	Description	Data
N/A	Ramp Length (in)	50.0	Yes	Ramp Slope (%)	7.1
No	Ramp Width (in)	47.5	Yes	Ramp XSlope (%)	2.7
N/A	Flare Type LT	N/A	N/A	Flare Type RT	N/A
N/A	Flare Slope LT (%)	N/A	N/A	Flare Slope RT (%)	N/A
N/A	Flare Traversable LT?	N/A	N/A	Flare Traversable RT?	N/A
N/A	Landing Length (in)	N/A	N/A	DWS Provided?	N/A
N/A	Landing Width (in)	N/A	N/A	DWS Contrast?	N/A
N/A	Landing Slope (%)	N/A	N/A	DWS Length (in)	N/A
N/A	Landing X Slope (%)	N/A	N/A	DWS Full Width?	N/A
N/A	Landing Curb? (Y/N)	N/A	N/A	DWS Offset (in)	N/A
N/A	Shared Landing?	N/A			
N/A	Gutter Ponding?	N/A	N/A	Gutter Slope (%)	N/A
N/A	Gutter Lip Ht (in)	N/A	N/A	Gutter X Slope (%)	N/A
N/A	Painted X Walk1?	No	N/A	Painted X Walk2?	N/A
	X Walk 1 Direction	To NE		X Walk 2 Direction	N/A
N/A	X Walk 1 Width (in)	N/A	N/A	X Walk 2 Width (in)	N/A
	X Walk 1 Slope (%)	3.0		X Walk 2 Slope (%)	N/A
	X Walk 1 X Slope (%)	4.9		X Walk 2 X Slope (%)	N/A

Remove & Replace Entire Ramp.
