Access Compliance Report Public Rights-of-Way (Curb Ramps)

Intersection ID: 7422Main Street:BOXMEER_DRCross Street:STATESVILLE_RDLocation:NEADA ID: 3D9BA8290B34Ramp Type:PerpInitial Pass/Fail:FailOverall Compliance:NoSeverity Score:21.25

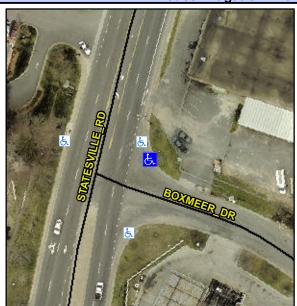
Field Measurements/Component Compliance							
Compliance Description		Data	Comp	liance	Description	Data	
N/A	Ramp Length (in)	62.0	No	Ramp	Slope (%)	11.0	
No	Ramp Width (in)	36.0	Yes	Ramp	XSlope (%)	1.2	
N/A	Flare Type LT	N/A	N/A	Flare ⁻	Гуре RT	N/A	
N/A	Flare Slope LT (%)	N/A	N/A	Flare	Slope RT (%)	N/A	
N/A	Flare Traversable LT?	N/A	N/A	Flare ⁻	Traversable RT?	N/A	
N/A	Landing Length (in)	N/A	N/A	DWS	Provided?	N/A	
N/A	Landing Width (in)	N/A	N/A	DWS	Contrast?	N/A	
N/A	Landing Slope (%)	N/A	N/A	DWS	Length (in)	N/A	
N/A	Landing X Slope (%)	N/A	N/A	DWS	Full Width?	N/A	
N/A	Landing Curb? (Y/N)	N/A	N/A	DWS	Offset (in)	N/A	
N/A	Shared Landing?	N/A					
N/A	Gutter Ponding?	N/A	N/A	Gutter	Slope (%)	N/A	
N/A	Gutter Lip Ht (in)	N/A	N/A	Gutter	X Slope (%)	N/A	
N/A	Painted X Walk1?	No	N/A	Painte	d X Walk2?	N/A	
	X Walk 1 Direction	To SW		X Wall	k 2 Direction	N/A	
N/A	X Walk 1 Width (in)	N/A	N/A	X Wall	k 2 Width (in)	N/A

Possible Solutions:						
Remove & Replace Entire Ramp.						
Surveyer Nates:						
Surveyor Notes:						
N/A						
PROW/ADA:						
Not Found, R304.5.1, R304.2.2						
, , , , , , , , , , , , , , , , , , , ,
