Access Compliance Report

Public Rights-of-Way

(Curb Ramps)

Intersection ID: 27772	Main Street: BRIARWICK_LN	Cross Street: NORTH_COMMUNITY_HOUSE_RD	Location: SW
ADA ID: 3DB77FBF6448	Ramp Type: Combination1	Initial Pass/Fail: Fail	Overall Compliance: No Severity Score: 33.75

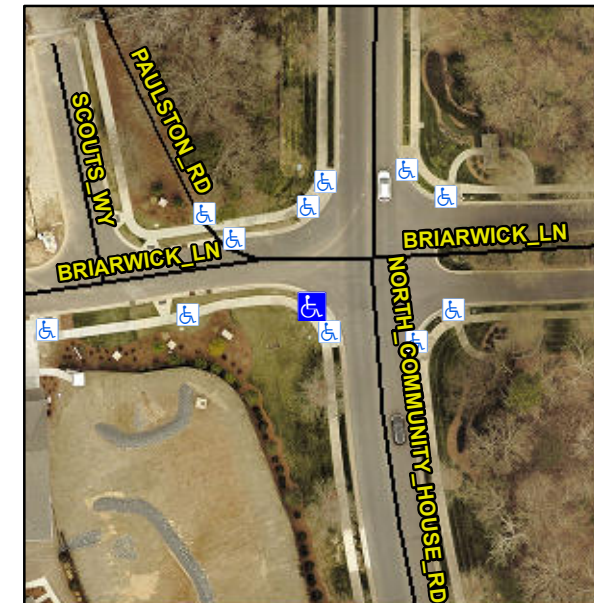
LT RP < 5%

Not Found, R304.5.1, R304.2.2, R304.5.3

Compliance	Description	Data	Compliance	Description	Data
N/A	Ramp Length LT (in)	52.0	N/A	Ramp Length RT (in)	48.0
Yes	Ramp Width LT (in)	56.0	Yes	Ramp Width RT (in)	56.0
Yes	Ramp Slope LT (%)	4.3	Yes	Ramp Slope RT (%)	8.2
Yes	Ramp XSlope LT (%)	1.4	No	Ramp XSlope RT (%)	2.5
N/A	Ramp Length (in)	52.0	No	Ramp Slope (%)	11.8
No	Ramp Width (in)	47.5	No	Ramp XSlope (%)	5.2
N/A	Flare Type LT	N/A	N/A	Flare Type RT	N/A
N/A	Flare Slope LT (%)	N/A	N/A	Flare Slope RT (%)	N/A
N/A	Flare Traversable LT?	N/A	N/A	Flare Traversable RT?	N/A
N/A	Landing Length (in)	N/A	N/A	DWS Provided?	N/A
N/A	Landing Width (in)	N/A	N/A	DWS Contrast?	N/A
N/A	Landing Slope (%)	N/A	N/A	DWS Length (in)	N/A
N/A	Landing X Slope (%)	N/A	N/A	DWS Full Width?	N/A
N/A	Landing Curb? (Y/N)	N/A	N/A	DWS Offset (in)	N/A
N/A	Shared Landing?	N/A			
N/A	Gutter Ponding?	N/A	N/A	Gutter Slope (%)	N/A
N/A	Gutter Lip Ht (in)	N/A	N/A	Gutter X Slope (%)	N/A
N/A	Painted X Walk1?	No	N/A	Painted X Walk2?	N/A

Remove & Replace Entire Ramp.
