Access Compliance Report

Public Rights-of-Way

(Curb Ramps)

Intersection ID: 43664	Main Street: HUNTINGTON_MEADOW_LN	Cross Street: FERGUSON_FOREST_DR	Location: SW
ADA ID: 3E5D6FE981B1	Ramp Type: Combination1	Initial Pass/Fail: Fail	Overall Compliance: No
Codes/Mitigation Info/Possible Solution		Field Measurements/Component Compliance	
Severity Score: 46.25

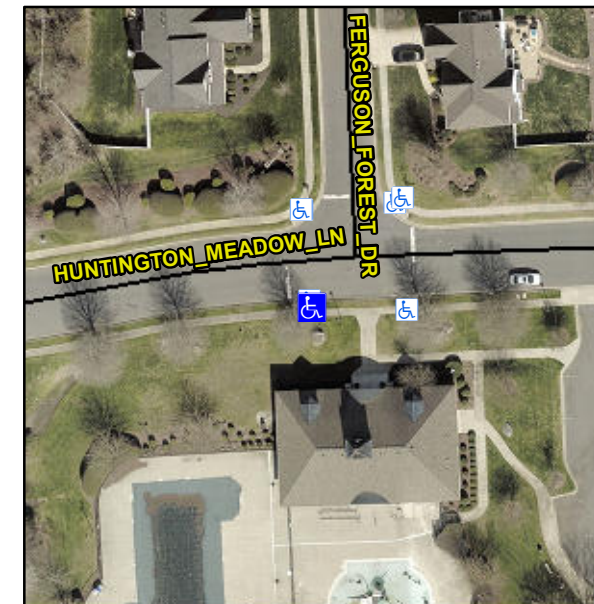
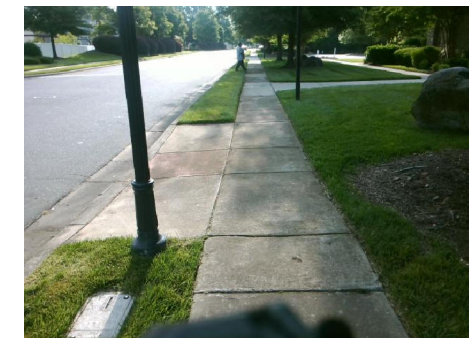
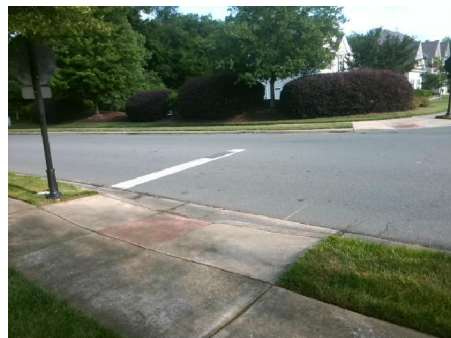
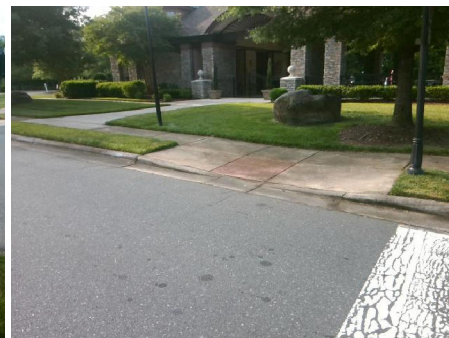
LT RP < 5%

R304.5.1, R304.2.2, R304.5.3

Compliance	Description	Data	Compliance	Description	Data
N/A	Ramp Length LT (in)	72.0	N/A	Ramp Length RT (in)	73.0
No	Ramp Width LT (in)	47.0	Yes	Ramp Width RT (in)	48.0
Yes	Ramp Slope LT (%)	4.2	Yes	Ramp Slope RT (%)	5.7
Yes	Ramp XSlope LT (%)	1.4	No	Ramp XSlope RT (%)	7.4
N/A	Ramp Length (in)	48.0	No	Ramp Slope (%)	8.6
Yes	Ramp Width (in)	48.0	Yes	Ramp XSlope (%)	1.2
N/A	Flare Type LT	N/A	N/A	Flare Type RT	N/A
N/A	Flare Slope LT (%)	N/A	N/A	Flare Slope RT (%)	N/A
N/A	Flare Traversable LT?	N/A	N/A	Flare Traversable RT?	N/A
N/A	Landing Length (in)	N/A	N/A	DWS Provided?	N/A
N/A	Landing Width (in)	N/A	N/A	DWS Contrast?	N/A
N/A	Landing Slope (%)	N/A	N/A	DWS Length (in)	N/A
N/A	Landing X Slope (%)	N/A	N/A	DWS Full Width?	N/A
N/A	Landing Curb? (Y/N)	N/A	N/A	DWS Offset (in)	N/A
N/A	Shared Landing?	N/A			
N/A	Gutter Ponding?	N/A	N/A	Gutter Slope (%)	N/A
N/A	Gutter Lip Ht (in)	N/A	N/A	Gutter X Slope (%)	N/A
N/A	Painted X Walk1?	No	N/A	Painted X Walk2?	N/A

Possible Solutions:

Remove & Replace Entire Ramp.
