Access Compliance Report

Public Rights-of-Way

(Curb Ramps)

Intersection ID: 27738	Main Street: JAMES JACK LN	Cross Street: VILLALONGA LN	Location: W
ADA ID: 3E71342235D9	Ramp Type: PerpDiag	Initial Pass/Fail: Fail	Overall Compliance: No
Codes/Mitigation Info/Possible Solution			Severity Score: 17.5
			Field Measurements/Component Compliance

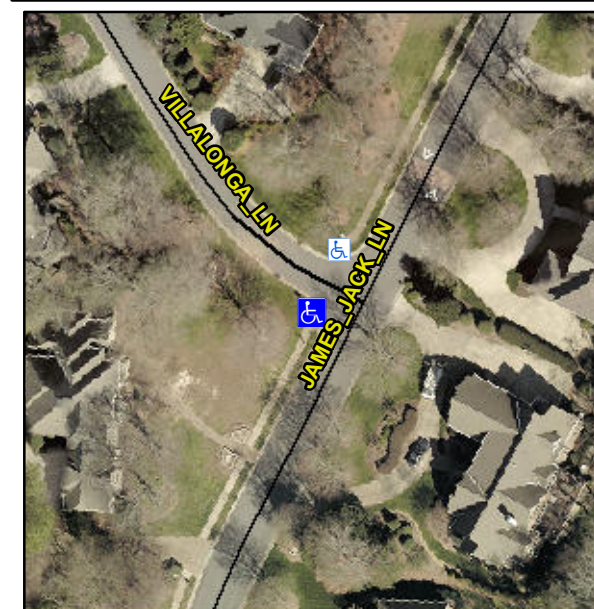
PROW/ADA:

R304.5.1

Compliance	Description	Data	Compliance	Description	Data
N/A	Ramp Length (in)	50.0	Yes	Ramp Slope (%)	7.5
No	Ramp Width (in)	35.0	Yes	Ramp XSlope (%)	1.1
N/A	Flare Type LT	N/A	N/A	Flare Type RT	N/A
N/A	Flare Slope LT (%)	N/A	N/A	Flare Slope RT (%)	N/A
N/A	Flare Traversable LT?	N/A	N/A	Flare Traversable RT?	N/A
N/A	Landing Length (in)	N/A	N/A	DWS Provided?	N/A
N/A	Landing Width (in)	N/A	N/A	DWS Contrast?	N/A
N/A	Landing Slope (%)	N/A	N/A	DWS Length (in)	N/A
N/A	Landing X Slope (%)	N/A	N/A	DWS Full Width?	N/A
N/A	Landing Curb? (Y/N)	N/A	N/A	DWS Offset (in)	N/A
N/A	Shared Landing?	N/A			
N/A	Gutter Ponding?	N/A	N/A	Gutter Slope (%)	N/A
N/A	Gutter Lip Ht (in)	N/A	N/A	Gutter X Slope (%)	N/A
N/A	Painted X Walk1?	No	N/A	Painted X Walk2?	No
	X Walk 1 Direction	To SE		X Walk 2 Direction	To NE
N/A	X Walk 1 Width (in)	N/A	N/A	X Walk 2 Width (in)	N/A
	X Walk 1 Slope (%)	1.5		X Walk 2 Slope (%)	2.0
	X Walk 1 X Slope (%)	3.8		X Walk 2 X Slope (%)	2.9

Possible Solutions:

Remove & Replace Curb Ramp With Two New Directional Ramps or Equivalent.
