Access Compliance Report Public Rights-of-Way (Curb Ramps)

Intersection ID: 24896 Main Street: GADWALL_CT Cross Street: KING_EIDER_DR Location: NE **Overall Compliance: No** ADA ID: 3EC8328661BE Ramp Type: Directional1 Initial Pass/Fail: Fail **Severity Score:** 12.5

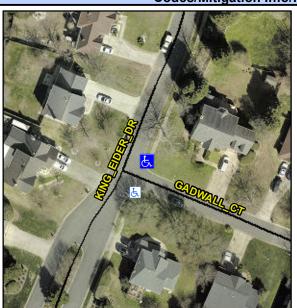
Field Measurements/Component Compliance									
Comp	liance Description	Data	Comp	liance	Description	Data			
N/A	Ramp Length (in)	21.0	N/A	Grad	e Break?	N/A			
Yes	Ramp Width (in)	48.0	N/A	Grad	e Break Slope (%)	0.0			
Yes	Ramp Slope (%)	1.4	N/A	Grad	e Break XSlope (%)	0.0			
No	Ramp XSlope (%)	5.5							
N/A	Flare Type LT	N/A	N/A	Flare	Type RT	N/A			
N/A	Flare Slope LT (%)	N/A	N/A	Flare	Slope RT (%)	0.0			
N/A	Flare Traversable LT?	N/A	N/A	Flare	Traversable RT?	N/A			
N/A	Landing Length (in)	0.0	N/A	DWS	Provided?	N/A			
N/A	Landing Width (in)	0.0	N/A	DWS	Contrast?	N/A			
N/A	Landing Slope (%)	0.0	N/A	DWS	Length (in)	N/A			
N/A	Landing X Slope (%)	0.0	N/A	DWS	Full Width?	N/A			
N/A	Landing Curb? (Y/N)	N/A	N/A	DWS	Offset LT (in)	N/A			
N/A	Shared Landing?	N/A	N/A	DWS	Offset RT (in)	N/A			
N/A	Gutter Ponding?	0.0	N/A	Gutte	er Slope (%)	N/A			
N/A	Gutter Lip Ht (in)	0.0	N/A	Gutte	er X Slope (%)	N/A			
N/A	Painted X Walk1?	No		Road	Slope (%)	3.2

Possible Solutions:
Remove & Replace Entire Ramp.
Surveyor Notes:
N/A
PROW/ADA:
R304.5.3
