Access Compliance Report

Public Rights-of-Way

(Curb Ramps)

Intersection ID: 10570	Main Street: HERRIN_AV	Cross Street: HOLT_ST	Location: SW
ADA ID: 3ED00AC432E9	Ramp Type: Combination2	Initial Pass/Fail: Fail	Overall Compliance: No
		Severity Score: 22.5

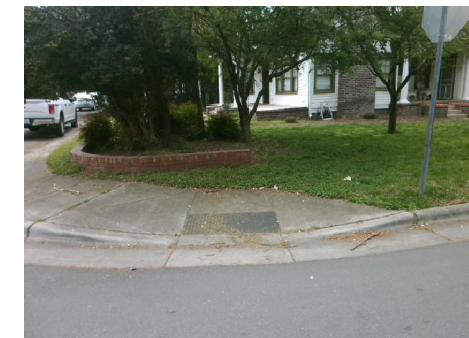
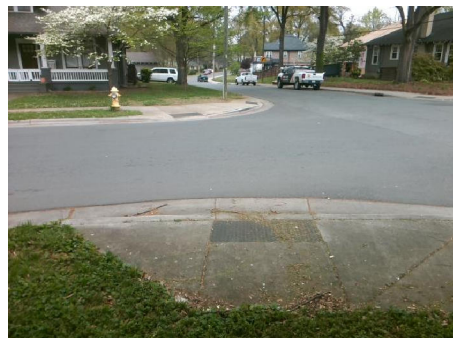
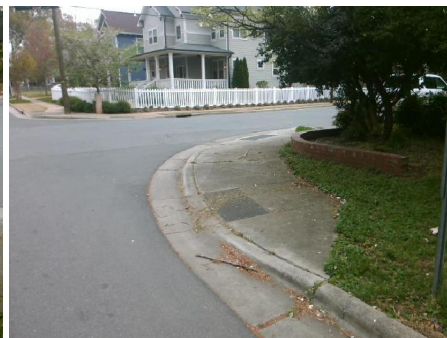
Not Found, R304.5.1, R304.3.2, R304.5.3

Compliance	Description	Data	Compliance	Description	Data
N/A	Ramp Length LT (in)	49.0	N/A	Ramp Length RT (in)	N/A
No	Ramp Width LT (in)	46.0	N/A	Ramp Width RT (in)	N/A
No	Ramp Slope LT (%)	8.9	N/A	Ramp Slope RT (%)	N/A
No	Ramp XSlope LT (%)	2.6	N/A	Ramp XSlope RT (%)	N/A
N/A	Ramp Length (in)	26.5	Yes	Ramp Slope (%)	6.3
Yes	Ramp Width (in)	48.0	Yes	Ramp XSlope (%)	0.7
N/A	Flare Type LT	N/A	N/A	Flare Type RT	N/A
N/A	Flare Slope LT (%)	N/A	N/A	Flare Slope RT (%)	N/A
N/A	Flare Traversable LT?	N/A	N/A	Flare Traversable RT?	N/A
N/A	Landing Length (in)	N/A	N/A	DWS Provided?	N/A
N/A	Landing Width (in)	N/A	N/A	DWS Contrast?	N/A
N/A	Landing Slope (%)	N/A	N/A	DWS Length (in)	N/A
N/A	Landing X Slope (%)	N/A	N/A	DWS Full Width?	N/A
N/A	Landing Curb? (Y/N)	N/A	N/A	DWS Offset (in)	N/A
N/A	Shared Landing?	N/A			
N/A	Gutter Ponding?	N/A	N/A	Gutter Slope (%)	N/A
N/A	Gutter Lip Ht (in)	N/A	N/A	Gutter X Slope (%)	N/A
N/A	Painted X Walk1?	No	N/A	Painted X Walk2?	N/A

X Walk 1 Direction	To NW		X Walk 2 Direction	N/A
	X Walk 1 Width (in)	N/A		X Walk 2 Width (in)	N/A
	X Walk 1 Slope (%)	0.2		X Walk 2 Slope (%)	N/A
	X Walk 1 X Slope (%)	2.0		X Walk 2 X Slope (%)	N/A
N/A	Ramp inside XWalk1?	N/A	N/A	Ramp inside XWalk2?	N/A
	Road Slope (%)	N/A		Clear Space?	N/A
	Road X Slope (%)	N/A	N/A	Clear Space to XWalk (in)	N/A
			N/A	Any Obstruction?	N/A
				Obstruction Type	N/A
			N/A	Storm Grate/Utility Hazard?	N/A
				Storm Grate/Utility Type	N/A
					N/A
Yes	Surface Condition? (G/P)	Good			
	Curb Slope (%)	16.2

Remove & Replace Entire Ramp.
