## **Access Compliance Report Public Rights-of-Way** (Curb Ramps)

Intersection ID: 20540 Main Street: FAIRVIEW\_RD Cross Street: VALENCIA\_TR Location: SE Severity Score: **Overall Compliance: No** ADA ID: 3EE5F29C2035 Ramp Type: Perp Initial Pass/Fail: Fail 37.5

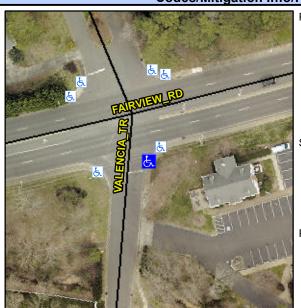
Field Measurements/Component Compliance							
Comp	liance Description	Data	Comp	liance Description	Data		
N/A	Ramp Length (in)	63.0	No	Ramp Slope (%)	10.2		
Yes	Ramp Width (in)	48.0	No	Ramp XSlope (%)	8.1		
N/A	Flare Type LT	N/A	N/A	Flare Type RT	N/A		
N/A	Flare Slope LT (%)	N/A	N/A	Flare Slope RT (%)	N/A		
N/A	Flare Traversable LT?	N/A	N/A	Flare Traversable RT?	N/A		
N/A	Landing Length (in)	N/A	N/A	DWS Provided?	N/A		
N/A	Landing Width (in)	N/A	N/A	DWS Contrast?	N/A		
N/A	Landing Slope (%)	N/A	N/A	DWS Length (in)	N/A		
N/A	Landing X Slope (%)	N/A	N/A	DWS Full Width?	N/A		
N/A	Landing Curb? (Y/N)	N/A	N/A	DWS Offset (in)	N/A		
N/A	Shared Landing?	N/A					
N/A	Gutter Ponding?	N/A	N/A	Gutter Slope (%)	N/A		
N/A	Gutter Lip Ht (in)	N/A	N/A	Gutter X Slope (%)	N/A		
N/A	Painted X Walk1?	No	N/A	Painted X Walk2?	N/A		
	X Walk 1 Direction	To W		X Walk 2 Direction	N/A		
N/A	X Walk 1 Width (in)	N/A	N/A	X Walk 2 Width (in)	N/A

X Walk 1 Slope (%)	0.5		X Walk 2 Slope (%)	N/A		
	X Walk 1 X Slope (%)	8.3		X Walk 2 X Slope (%)	N/A		
N/A	Ramp inside XWalk1?	N/A	N/A	Ramp inside XWalk2?	N/A		
	Road Slope (%)	N/A	N/A	Clear Space?	N/A		
	Road X Slope (%)	N/A	N/A	Clear Space to XWalk (in)	N/A		
N/A	Any Obstructions?	N/A	N/A	Storm Grate/Utility Hazard?	N/A		
	Obstruction Type			Storm Grate/Utility Type			
		N/A			N/A		
			Yes	Surface Condition? (G/P)	Good

Possible Solutions:	
Remove & Replace Entire Ramp.	!
	I
	ı
Surveyor Notes:	ı
N/A	!
t control of the cont	
PROW/ADA:	
Not Found, R304.2.2, R304.5.3	ı
110t 1 cana, 1100 11212, 1100 11010	1

1850.00
