Access Compliance Report Public Rights-of-Way (Curb Ramps)

Intersection ID: 46806 Main Street: ADLIN_AV Cross Street: RED_BIRCH_DR Location: NW

ADA ID: 3EEE967340E8 Ramp Type: PerpDiag Initial Pass/Fail: Fail Overall Compliance: No Severity Score: 13.75

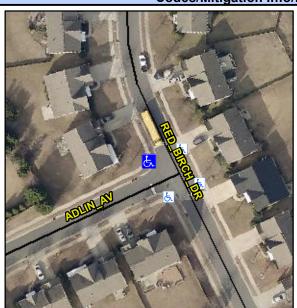
Not Found, R304.2.2, R304.5.3

Compliance Description Data Compliance Description Data					
Compliance Description		Data			Data
N/A	Ramp Length (in)	48.0	No 	Ramp Slope (%)	8.9
Yes	Ramp Width (in)	49.5	No	Ramp XSlope (%)	3.0
N/A	Flare Type LT	N/A	N/A	Flare Type RT	N/A
N/A	Flare Slope LT (%)	N/A	N/A	Flare Slope RT (%)	N/A
N/A	Flare Traversable LT?	N/A	N/A	Flare Traversable RT?	N/A
N/A	Landing Length (in)	N/A	N/A	DWS Provided?	N/A
N/A	Landing Width (in)	N/A	N/A	DWS Contrast?	N/A
N/A	Landing Slope (%)	N/A	N/A	DWS Length (in)	N/A
N/A	Landing X Slope (%)	N/A	N/A	DWS Full Width?	N/A
N/A	Landing Curb? (Y/N)	N/A	N/A	DWS Offset (in)	N/A
N/A	Shared Landing?	N/A			
N/A	Gutter Ponding?	N/A	N/A	Gutter Slope (%)	N/A
N/A	Gutter Lip Ht (in)	N/A	N/A	Gutter X Slope (%)	N/A
N/A	Painted X Walk1?	No	N/A	Painted X Walk2?	No
	X Walk 1 Direction	To S		X Walk 2 Direction	То Е
N/A	X Walk 1 Width (in)	N/A	N/A	X Walk 2 Width (in)	N/A
	X Walk 1 Slope (%)	0.7		X Walk 2 Slope (%)	2.6

X Walk 1 X Slope (%)	1.1		X Walk 2 X Slope (%)	0.7
N/A	Ramp inside XWalk1?	N/A	N/A	Ramp inside XWalk2?	N/A
	Road Slope (%)	1.6	N/A	Clear Space?	N/A
	Road X Slope (%)	0.3	N/A	Clear Space to XWalk (in)	N/A
N/A	Any Obstructions?	N/A	N/A	Storm Grate/Utility Hazard?	N/A
	Obstruction Type			Storm Grate/Utility Type	
		N/A			N/A
			Yes	Surface Condition? (G/P)	Good
	7 7	'	•	. ,

Remove & Replace Curb Ramp With Two New Directional Ramps or Equivalent.

Total Cost: \$ 3200.00
