Access Compliance Report

Public Rights-of-Way

(Curb Ramps)

Intersection ID: 10030604	Main Street: LOMA_LINDA_LN	Cross Street: N/A	Location: W
ADA ID: 3FBEC8F256F9	Ramp Type: Perp	Initial Pass/Fail: Fail	Overall Compliance: No
Severity Score: 12.5			
Codes/Mitigation Info/Possible Solution		Field Measurements/Component Compliance

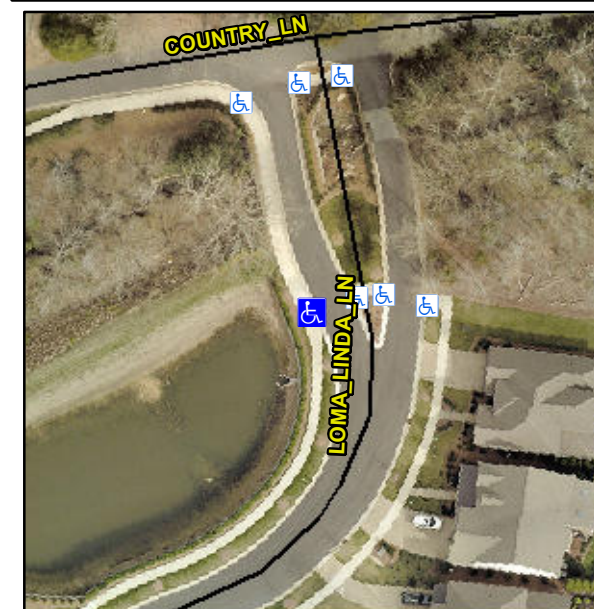
Not Found, R304.5.3

Compliance	Description	Data	Compliance	Description	Data
N/A	Ramp Length (in)	83.0	Yes	Ramp Slope (%)	8.2
Yes	Ramp Width (in)	48.0	No	Ramp XSlope (%)	6.2
N/A	Flare Type LT	N/A	N/A	Flare Type RT	N/A
N/A	Flare Slope LT (%)	N/A	N/A	Flare Slope RT (%)	N/A
N/A	Flare Traversable LT?	N/A	N/A	Flare Traversable RT?	N/A
N/A	Landing Length (in)	N/A	N/A	DWS Provided?	N/A
N/A	Landing Width (in)	N/A	N/A	DWS Contrast?	N/A
N/A	Landing Slope (%)	N/A	N/A	DWS Length (in)	N/A
N/A	Landing X Slope (%)	N/A	N/A	DWS Full Width?	N/A
N/A	Landing Curb? (Y/N)	N/A	N/A	DWS Offset (in)	N/A
N/A	Shared Landing?	N/A			
N/A	Gutter Ponding?	N/A	N/A	Gutter Slope (%)	N/A
N/A	Gutter Lip Ht (in)	N/A	N/A	Gutter X Slope (%)	N/A
N/A	Painted X Walk1?	No	N/A	Painted X Walk2?	N/A
	X Walk 1 Direction	To E		X Walk 2 Direction	N/A
N/A	X Walk 1 Width (in)	N/A	N/A	X Walk 2 Width (in)	N/A
	X Walk 1 Slope (%)	1.2		X Walk 2 Slope (%)	N/A
	X Walk 1 X Slope (%)	3.7		X Walk 2 X Slope (%)	N/A

Remove & Replace Entire Ramp.

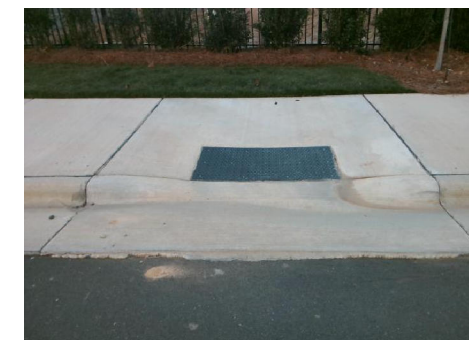
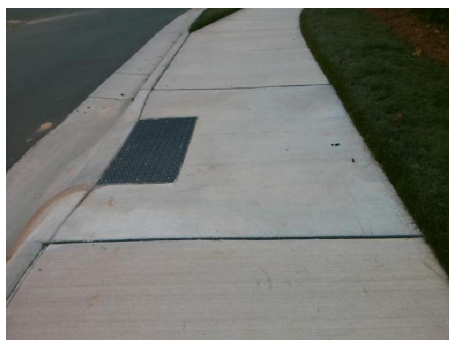
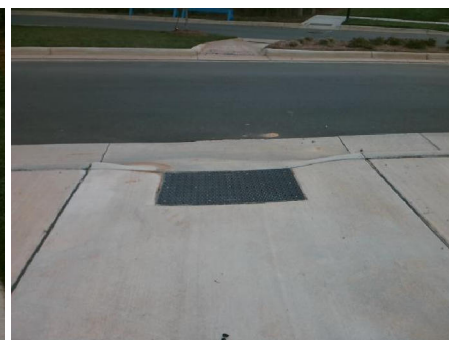
N/A	Ramp inside XWalk1?	N/A	N/A	Ramp inside XWalk2?	N/A
	Road Slope (%)	N/A	N/A	Clear Space?	N/A
	Road X Slope (%)	N/A	N/A	Clear Space to XWalk (in)	N/A
N/A	Any Obstructions?	N/A	N/A	Storm Grate/Utility Hazard?	N/A
	Obstruction Type			Storm Grate/Utility Type	
		N/A			N/A
		Yes		Surface Condition? (G/P)	Good
