# Access Compliance Report

## Public Rights-of-Way

### (Curb Ramps)

| Intersection ID: 9386 | Main Street: DUCKWOOD_LN | Cross Street: SAM_DEE_RD | Location: SW |

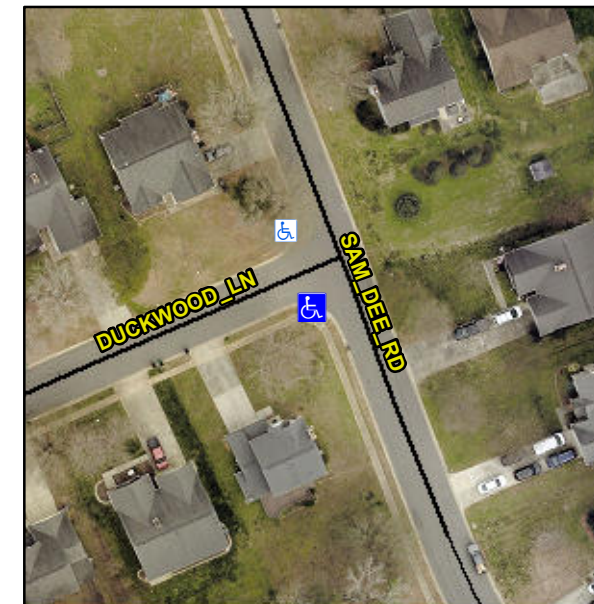
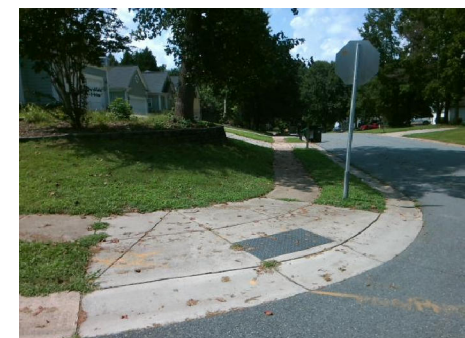
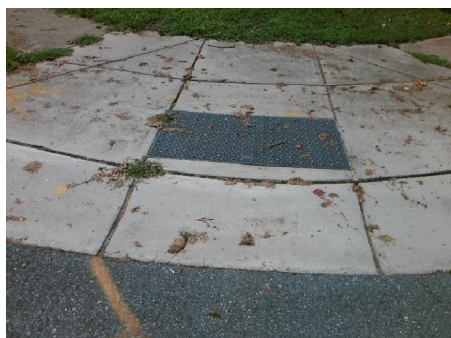
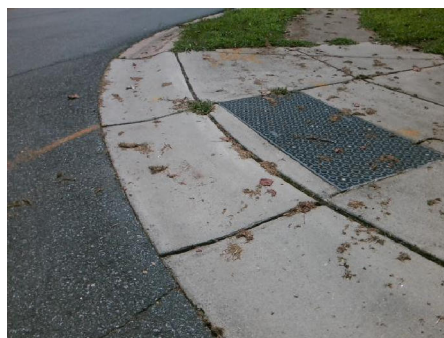
**Not Found, R304.5.1, R304.5.3**

| Compliance | Description | Data | Compliance | Description | Data |
|---|---|---|---|---|---|
| No | Ramp Width (in) | 47.0 | No | BlendTrans XSlope (%) | 5.5 |
| | | | No | Curb Slope (%) | 16.4 |

**Remove & Replace Curb Ramp With Two New Directional Ramps or Equivalent.**
