Access Compliance Report

Public Rights-of-Way

(Curb Ramps)

Intersection ID: 52127	Main Street: VALLEYDALE_RD	Cross Street: FRED_D_ALEXANDER_BV	Location: S
ADA ID: 412AF1DB66B1	Ramp Type: Combination1	Initial Pass/Fail: Fail	Overall Compliance: No
			Severity Score: 13.75

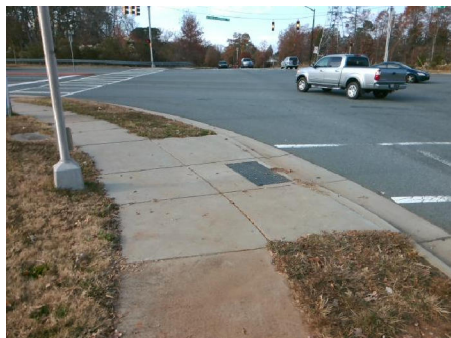
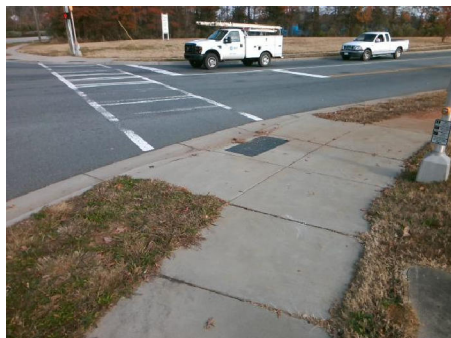
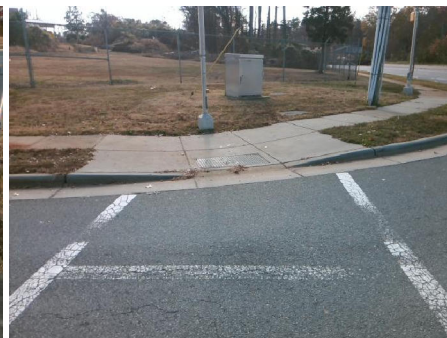
RP < 5%

Not Found, R304.5.3, R304.3.2

Remove & Replace Entire Ramp.
