Access Compliance Report

Public Rights-of-Way

(Curb Ramps)

Intersection ID: 8391	Main Street: LASALLE_ST	Cross Street: MADRID_ST	Location: NW
ADA ID: 41426EA75939	Ramp Type: PerpDiag	Initial Pass/Fail: Fail	Overall Compliance: No
Severity Score: 55			
Codes/Mitigation Info/Possible Solution		Field Measurements/Component Compliance

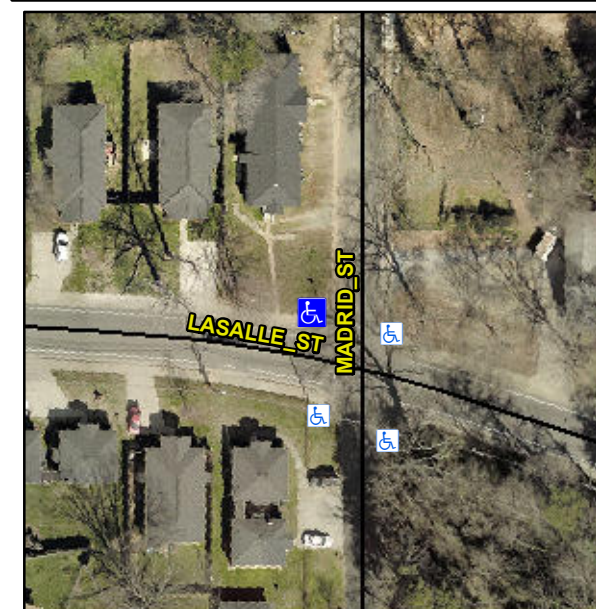
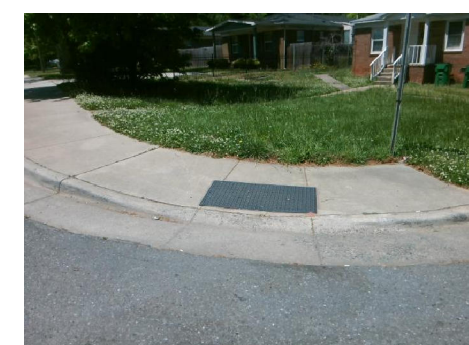
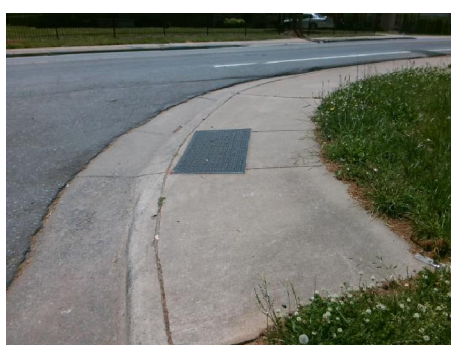
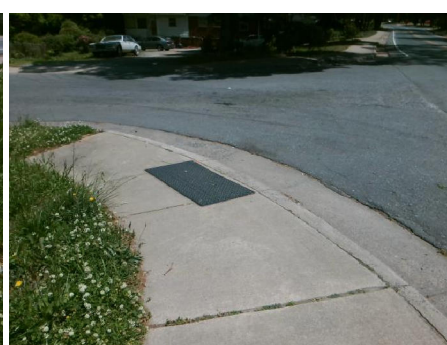
Not Found, R304.5.1, R304.2.2, R304.5.3

Compliance	Description	Data	Compliance	Description	Data
N/A	Ramp Length (in)	60.0	No	Ramp Slope (%)	9.3
No	Ramp Width (in)	35.5	No	Ramp XSlope (%)	7.7
N/A	Flare Type LT	N/A	N/A	Flare Type RT	N/A
N/A	Flare Slope LT (%)	N/A	N/A	Flare Slope RT (%)	N/A
N/A	Flare Traversable LT?	N/A	N/A	Flare Traversable RT?	N/A
N/A	Landing Length (in)	N/A	N/A	DWS Provided?	N/A
N/A	Landing Width (in)	N/A	N/A	DWS Contrast?	N/A
N/A	Landing Slope (%)	N/A	N/A	DWS Length (in)	N/A
N/A	Landing X Slope (%)	N/A	N/A	DWS Full Width?	N/A
N/A	Landing Curb? (Y/N)	N/A	N/A	DWS Offset (in)	N/A
N/A	Shared Landing?	N/A			
N/A	Gutter Ponding?	N/A	N/A	Gutter Slope (%)	N/A
N/A	Gutter Lip Ht (in)	N/A	N/A	Gutter X Slope (%)	N/A
N/A	Painted X Walk1?	No	N/A	Painted X Walk2?	No
	X Walk 1 Direction	To S		X Walk 2 Direction	To E
N/A	X Walk 1 Width (in)	N/A	N/A	X Walk 2 Width (in)	N/A
	X Walk 1 Slope (%)	0.2		X Walk 2 Slope (%)	3.6
	X Walk 1 X Slope (%)	3.0		X Walk 2 X Slope (%)	4.2

N/A	Ramp inside XWalk1?	N/A	N/A	Ramp inside XWalk2?	N/A
	Road Slope (%)	4.8	N/A	Clear Space?	N/A
	Road X Slope (%)	4.5	N/A	Clear Space to XWalk (in)	N/A
N/A	Any Obstructions?	N/A	N/A	Storm Grate/Utility Hazard?	N/A
	Obstruction Type			Storm Grate/Utility Type	
		N/A			N/A
			Yes	Surface Condition? (G/P)	Good

Remove & Replace Curb Ramp With Two New Directional Ramps or Equivalent.
