Access Compliance Report Public Rights-of-Way (Curb Ramps)

Intersection ID: 10144Main Street: FONTANA_AVCross Street: VOGEL_CTLocation:SEADA ID: 4153997D2C8FRamp Type: PerpInitial Pass/Fail: FailOverall Compliance: NoSeverity Score: 12.5

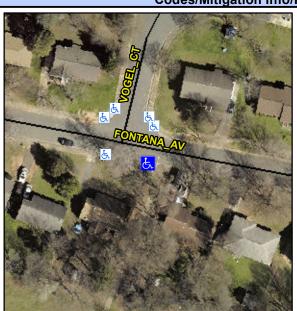
Field Measurements/Component Compliance						
Comp	liance Description	Data	Comp	liance Description	Data	
N/A	Ramp Length (in)	61.0	No	Ramp Slope (%)	10.7	
Yes	Ramp Width (in)	48.0	Yes	Ramp XSlope (%)	0.3	
N/A	Flare Type LT	N/A	N/A	Flare Type RT	N/A	
N/A	Flare Slope LT (%)	N/A	N/A	Flare Slope RT (%)	N/A	
N/A	Flare Traversable LT?	N/A	N/A	Flare Traversable RT?	N/A	
N/A	Landing Length (in)	N/A	N/A	DWS Provided?	N/A	
N/A	Landing Width (in)	N/A	N/A	DWS Contrast?	N/A	
N/A	Landing Slope (%)	N/A	N/A	DWS Length (in)	N/A	
N/A	Landing X Slope (%)	N/A	N/A	DWS Full Width?	N/A	
N/A	Landing Curb? (Y/N)	N/A	N/A	DWS Offset (in)	N/A	
N/A	Shared Landing?	N/A				
N/A	Gutter Ponding?	N/A	N/A	Gutter Slope (%)	N/A	
N/A	Gutter Lip Ht (in)	0.75	N/A	Gutter X Slope (%)	N/A	
N/A	Painted X Walk1?	No	N/A	Painted X Walk2?	N/A	
	X Walk 1 Direction	To N		X Walk 2 Direction	N/A	
N/A	X Walk 1 Width (in)	N/A	N/A	X Walk 2 Width (in)	N/A	
	X Walk 1 Slope (%)	1.3		X Walk 2 Slope (%)	N/A

Possible Solutions:	<u>c</u>
Remove & Replace Entire Ramp.	
·	Y
	N
	N
	N
	N
Surveyor Notes:	N
N/A	N
	N
	N
	N
PROW/ADA:	N
Not Found, R304.2.2	N
	N
	N
	N
