# Access Compliance Report

## Public Rights-of-Way

### (Curb Ramps)

Intersection ID: 24674	Main Street: CARMEL_RD	Cross Street: CARMEL_VISTA_LN	Location: SE
ADA ID: 41E130B3EDA4	Ramp Type: Perp	Initial Pass/Fail: Fail	Overall Compliance: No
		Severity Score: 10

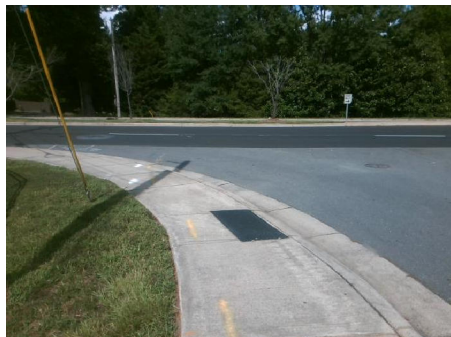
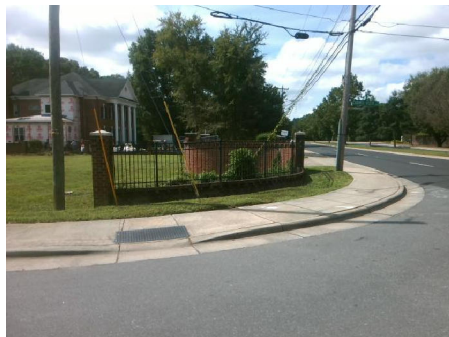
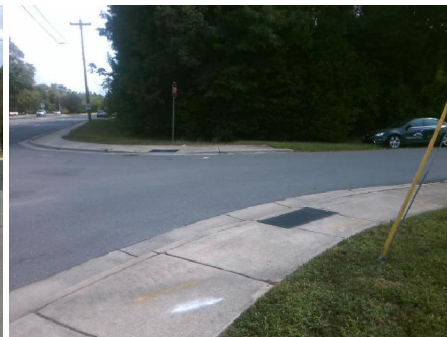
**Not Found, R304.5.1, R304.5.3**

Compliance	Description	Data	Compliance	Description	Data
N/A	Ramp Length (in)	57.0	Yes	Ramp Slope (%)	7.4
No	Ramp Width (in)	37.0	No	Ramp XSlope (%)	2.1
N/A	Flare Type LT	N/A	N/A	Flare Type RT	N/A
N/A	Flare Slope LT (%)	N/A	N/A	Flare Slope RT (%)	N/A
N/A	Flare Traversable LT?	N/A	N/A	Flare Traversable RT?	N/A
N/A	Landing Length (in)	N/A	N/A	DWS Provided?	N/A
N/A	Landing Width (in)	N/A	N/A	DWS Contrast?	N/A
N/A	Landing Slope (%)	N/A	N/A	DWS Length (in)	N/A
N/A	Landing X Slope (%)	N/A	N/A	DWS Full Width?	N/A
N/A	Landing Curb? (Y/N)	N/A	N/A	DWS Offset (in)	N/A
N/A	Shared Landing?	N/A			
N/A	Gutter Ponding?	N/A	N/A	Gutter Slope (%)	N/A
N/A	Gutter Lip Ht (in)	N/A	N/A	Gutter X Slope (%)	N/A
N/A	Painted X Walk1?	No	N/A	Painted X Walk2?	N/A
	X Walk 1 Direction	To NE		X Walk 2 Direction	N/A
N/A	X Walk 1 Width (in)	N/A	N/A	X Walk 2 Width (in)	N/A
	X Walk 1 Slope (%)	1.6		X Walk 2 Slope (%)	N/A
	X Walk 1 X Slope (%)	1.4		X Walk 2 X Slope (%)	N/A

**Remove & Replace Entire Ramp.**
