# Access Compliance Report

## Public Rights-of-Way

### (Curb Ramps)

| Intersection ID: 23778 | Main Street: COLONY_RD | Cross Street: LEE_REA_RD | Location: SW |

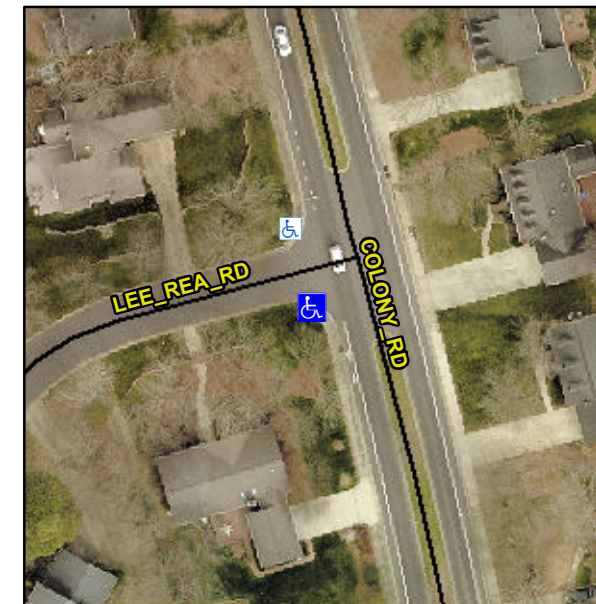
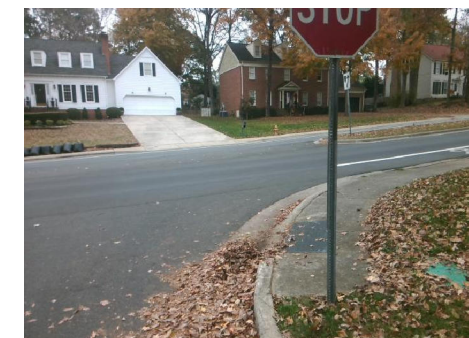
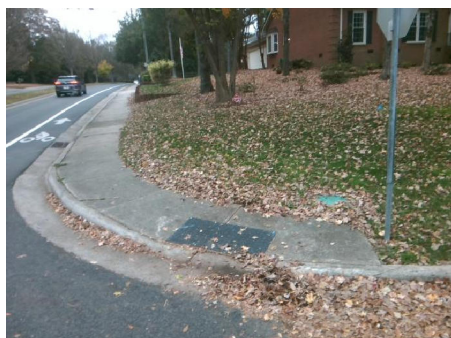
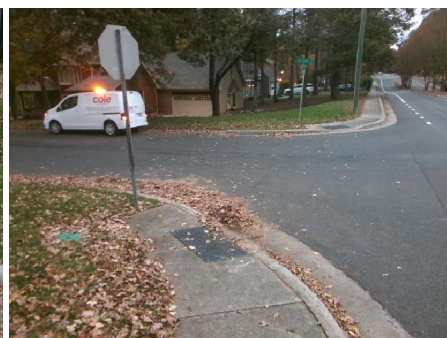
| ADA ID: 427ED05ACE55 | Ramp Type: PerpDiag | Initial Pass/Fail: Fail | Overall Compliance: No |

**Not Found, R304.2.2, R304.5.3**

| Compliance | Description | Data | Compliance | Description | Data |
|---|---|---|---|---|---|
| N/A | Ramp Length (in) | 48.0 | No | Ramp Slope (%) | 12.8 |
| Yes | Ramp Width (in) | 48.0 | No | Ramp XSlope (%) | 7.1 |

**Remove & Replace Curb Ramp With Two New Directional Ramps or Equivalent.**
