Access Compliance Report

Public Rights-of-Way

(Curb Ramps)

Intersection ID: 24183	Main Street: COMPTON_CT	Cross Street: LUTZEN_WAY_CT	Location: SW
ADA ID: 428105C53FFB	Ramp Type: PerpDiag	Initial Pass/Fail: Fail	Overall Compliance: No
		Severity Score: 8.75

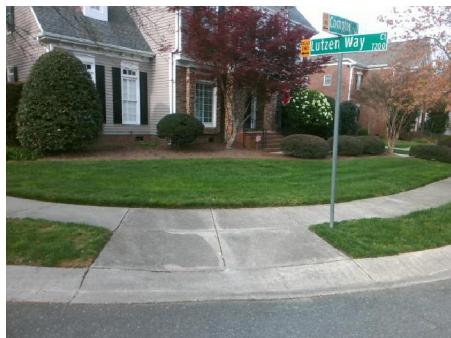
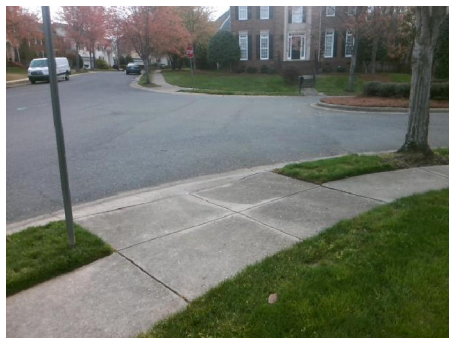
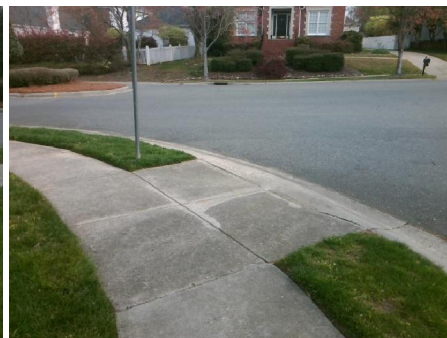
Not Found, R304.5.1

Compliance	Description	Data	Compliance	Description	Data
N/A	Ramp Length (in)	48.0	Yes	Ramp Slope (%)	7.3
No	Ramp Width (in)	46.0	Yes	Ramp XSlope (%)	0.6
N/A	Flare Type LT	N/A	N/A	Flare Type RT	N/A
N/A	Flare Slope LT (%)	N/A	N/A	Flare Slope RT (%)	N/A
N/A	Flare Traversable LT?	N/A	N/A	Flare Traversable RT?	N/A
N/A	Landing Length (in)	N/A	N/A	DWS Provided?	N/A
N/A	Landing Width (in)	N/A	N/A	DWS Contrast?	N/A
N/A	Landing Slope (%)	N/A	N/A	DWS Length (in)	N/A
N/A	Landing X Slope (%)	N/A	N/A	DWS Full Width?	N/A
N/A	Landing Curb? (Y/N)	N/A	N/A	DWS Offset (in)	N/A
N/A	Shared Landing?	N/A			
N/A	Gutter Ponding?	N/A	N/A	Gutter Slope (%)	N/A
N/A	Gutter Lip Ht (in)	N/A	N/A	Gutter X Slope (%)	N/A
N/A	Painted X Walk1?	No	N/A	Painted X Walk2?	No
	X Walk 1 Direction	To E		X Walk 2 Direction	To N
N/A	X Walk 1 Width (in)	N/A	N/A	X Walk 2 Width (in)	N/A
	X Walk 1 Slope (%)	6.0		X Walk 2 Slope (%)	4.2
	X Walk 1 X Slope (%)	2.6		X Walk 2 X Slope (%)	4.6

N/A	Ramp inside XWalk1?	N/A	N/A	Ramp inside XWalk2?	N/A
	Road Slope (%)	1.6	N/A	Clear Space?	N/A
	Road X Slope (%)	7.2	N/A	Clear Space to XWalk (in)	N/A
N/A	Any Obstructions?	N/A	N/A	Storm Grate/Utility Hazard?	N/A
	Obstruction Type			Storm Grate/Utility Type	
		N/A			N/A
			Yes	Surface Condition? (G/P)	Good

Remove & Replace Curb Ramp With Two New Directional Ramps or Equivalent.
