Access Compliance Report

Public Rights-of-Way

(Curb Ramps)

Intersection ID: 11480	Main Street: N_CEDAR_ST	Cross Street: W_5TH_ST	Location: N
ADA ID: 42C71F3E57E4	Ramp Type: Para	Initial Pass/Fail: Fail	Overall Compliance: No
			Severity Score: 26.25

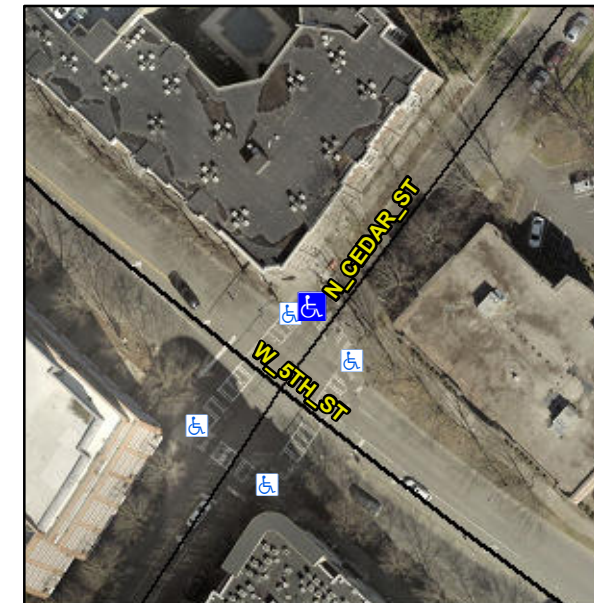
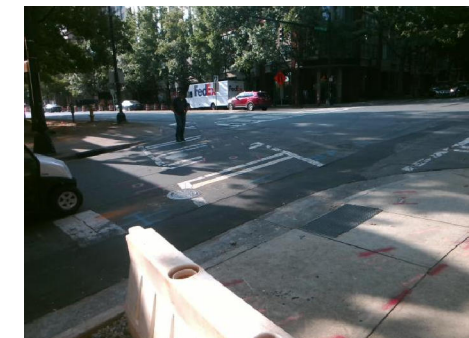
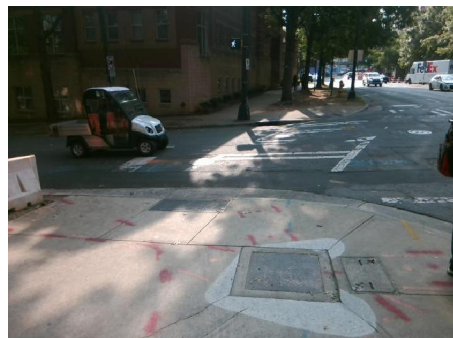
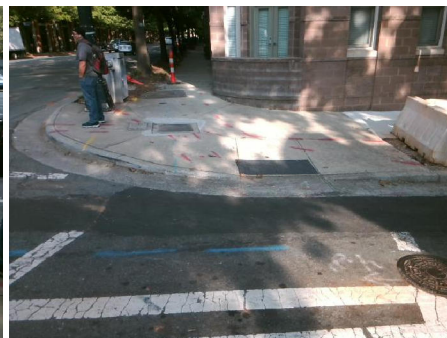
Compliance	Description	Data	Compliance	Description	Data
N/A	Ramp Length LT (in)	64.0	N/A	Ramp Length RT (in)	70.0
Yes	Ramp Width LT (in)	74.0	Yes	Ramp Width RT (in)	74.0
No	Ramp Slope LT (%)	14.8	Yes	Ramp Slope RT (%)	5.5
No	Ramp XSlope LT (%)	2.6	No	Ramp XSlope RT (%)	2.5
N/A	Landing Length (in)	N/A	N/A	DWS Provided?	N/A
N/A	Landing Width (in)	N/A	N/A	DWS Contrast?	N/A
N/A	Landing Slope (%)	N/A	N/A	DWS Length (in)	N/A
N/A	Landing X Slope (%)	N/A	N/A	DWS Full Width?	N/A
N/A	Landing Curb? (Y/N)	N/A	N/A	DWS Offset (in)	N/A
N/A	Shared Landing?	N/A			
N/A	Gutter Ponding?	N/A	N/A	Gutter Slope (%)	N/A
N/A	Gutter Lip Ht (in)	N/A	N/A	Gutter X Slope (%)	N/A
N/A	Painted X Walk1?	Yes	N/A	Painted X Walk2?	N/A
	X Walk 1 Direction	To SE		X Walk 2 Direction	N/A
N/A	X Walk 1 Width (in)	121.0	N/A	X Walk 2 Width (in)	N/A
	X Walk 1 Slope (%)	8.3		X Walk 2 Slope (%)	N/A
	X Walk 1 X Slope (%)	6.1		X Walk 2 X Slope (%)	N/A
N/A	Ramp inside XWalk1?	Yes	N/A	Ramp inside XWalk2?	N/A

Road Slope (%)	N/A	N/A	Clear Space?	N/A
	Road X Slope (%)	N/A	N/A	Clear Space to XWalk (in)	N/A
N/A	Any Obstructions?	N/A	N/A	Storm Grate/Utility Hazard?	N/A
	Obstruction Type			Storm Grate/Utility Type	
		N/A			N/A
			Yes	Surface Condition? (G/P)	Good
			N/A	Curb Slope (%)	2.7

Remove & Replace Entire Ramp.

R304.3.2, R304.5.3
