Access Compliance Report

Public Rights-of-Way

(Curb Ramps)

Intersection ID: 17190	Main Street: MURRAYHILL_RD	Cross Street: SCALEYBARK_RD	Location: S
ADA ID: 4350C0C4D668	Ramp Type: Combination2Diag	Initial Pass/Fail: Fail	Overall Compliance: No
Severity Score: 0			
Codes/Mitigation Info/Possible Solution		Field Measurements/Component Compliance

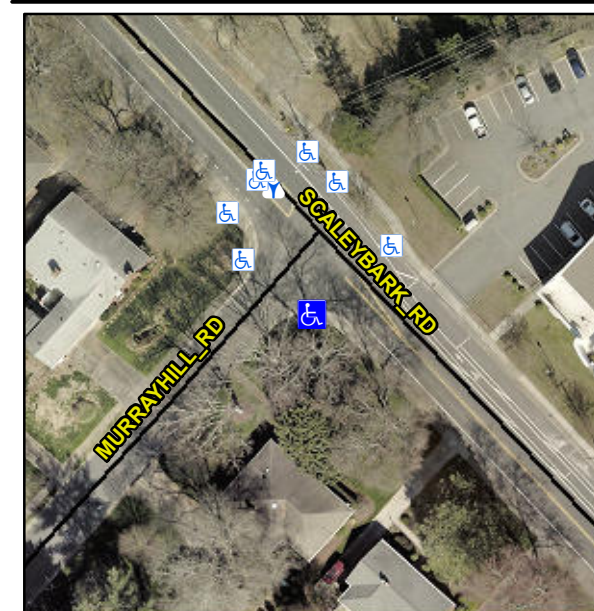
Not Found, R304.5.1, R304.5.3

Compliance	Description	Data	Compliance	Description	Data
N/A	Ramp Length LT (in)	48.0	N/A	Ramp Length RT (in)	N/A
No	Ramp Width LT (in)	34.0	N/A	Ramp Width RT (in)	N/A
Yes	Ramp Slope LT (%)	5.2	N/A	Ramp Slope RT (%)	N/A
No	Ramp XSlope LT (%)	3.2	N/A	Ramp XSlope RT (%)	N/A
N/A	Ramp Length (in)	24.0	Yes	Ramp Slope (%)	4.3
Yes	Ramp Width (in)	60.0	Yes	Ramp XSlope (%)	0.1
N/A	Flare Type LT	N/A	N/A	Flare Type RT	N/A
N/A	Flare Slope LT (%)	N/A	N/A	Flare Slope RT (%)	N/A
N/A	Flare Traversable LT?	N/A	N/A	Flare Traversable RT?	N/A
N/A	Landing Length (in)	N/A	N/A	DWS Provided?	N/A
N/A	Landing Width (in)	N/A	N/A	DWS Contrast?	N/A
N/A	Landing Slope (%)	N/A	N/A	DWS Length (in)	N/A
N/A	Landing X Slope (%)	N/A	N/A	DWS Full Width?	N/A
N/A	Landing Curb? (Y/N)	N/A	N/A	DWS Offset (in)	N/A
N/A	Shared Landing?	N/A			
N/A	Gutter Ponding?	N/A	N/A	Gutter Slope (%)	N/A
N/A	Gutter Lip Ht (in)	N/A	N/A	Gutter X Slope (%)	N/A
N/A	Painted X Walk1?	No	N/A	Painted X Walk2?	No

Remove & Replace Curb Ramp With Two New Directional Ramps or Equivalent.
