Access Compliance Report Public Rights-of-Way (Curb Ramps)

Intersection ID: 24384 Main Street: BIRNEN_DR Cross Street: N_VICKSBURG_PARK_CT Location: N

ADA ID: 4373B397DF9D Ramp Type: PerpDiag Initial Pass/Fail: Fail Overall Compliance: No Severity Score: 8.75

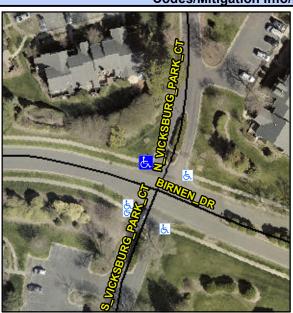
PROW/ADA:
Not Found, R304.5.1

Compliance Description D		Data	Compliance Description		Data
N/A	Ramp Length (in)	44.0	Yes	Ramp Slope (%)	5.1
No	Ramp Width (in)	44.0	Yes	Ramp XSlope (%)	1.7
N/A	Flare Type LT	N/A	N/A	Flare Type RT	N/A
N/A	Flare Slope LT (%)	N/A	N/A	Flare Slope RT (%)	N/A
N/A	Flare Traversable LT?	N/A	N/A	Flare Traversable RT?	N/A
N/A	Landing Length (in)	N/A	N/A	DWS Provided?	N/A
N/A	Landing Width (in)	N/A	N/A	DWS Contrast?	N/A
N/A	Landing Slope (%)	N/A	N/A	DWS Length (in)	N/A
N/A	Landing X Slope (%)	N/A	N/A	DWS Full Width?	N/A
N/A	Landing Curb? (Y/N)	N/A	N/A	DWS Offset (in)	N/A
N/A	Shared Landing?	N/A			
N/A	Gutter Ponding?	N/A	N/A	Gutter Slope (%)	N/A
N/A	Gutter Lip Ht (in)	N/A	N/A	Gutter X Slope (%)	N/A
N/A	Painted X Walk1?	No	N/A	Painted X Walk2?	No
	X Walk 1 Direction	To SW		X Walk 2 Direction	To SE
N/A	X Walk 1 Width (in)	N/A	N/A	X Walk 2 Width (in)	N/A
	X Walk 1 Slope (%)	1.6		X Walk 2 Slope (%)	2.5
	X Walk 1 X Slope (%)	2.2		X Walk 2 X Slope (%)	2.4

N/A	Ramp inside XWalk1?	N/A	N/A	Ramp inside XWalk2?	N/A
	Road Slope (%)	0.3	N/A	Clear Space?	N/A
	Road X Slope (%)	0.6	N/A	Clear Space to XWalk (in)	N/A
N/A	Any Obstructions?	N/A	N/A	Storm Grate/Utility Hazard?	N/A
	Obstruction Type			Storm Grate/Utility Type	
		N/A			N/A
			Yes	Surface Condition? (G/P)	Good

Remove & Replace Curb Ramp With
Two New Directional Ramps or
Equivalent.
