# Access Compliance Report

## Public Rights-of-Way

| Intersection ID: 19146 | Main Street: TYVOLA_RD | Cross Street: WEDGEWOOD_DR | Location: NE |
| ADA ID: 43DDFB5763A0 | Ramp Type: BlendTrans2 | Initial Pass/Fail: Pass | Overall Compliance: No |

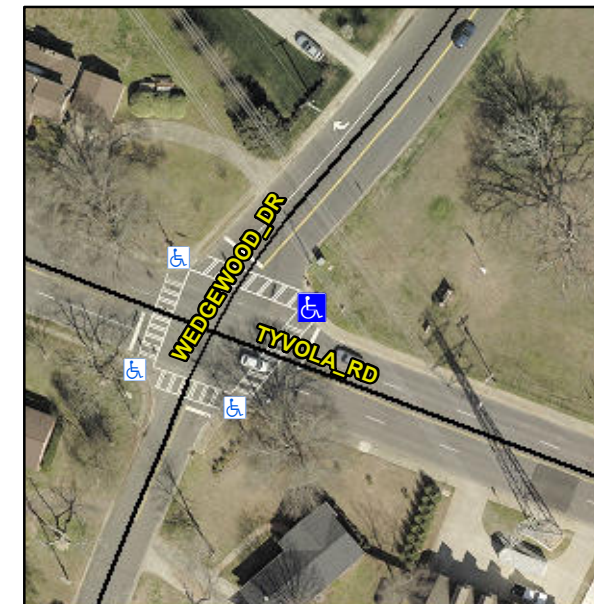
**Not Found, R305, R302.7, R302.7.2, R304.5.4**

| Compliance | Description | Data | Compliance | Description | Data |
|---|---|---|---|---|---|
| N/A | Landing Length (in) | N/A | No | DWS Provided? | No |
| No | Gutter Ponding? | Yes | No | Gutter Slope (%) | 5.3 |
| No | Gutter Lip Ht (in) | 0.5 | Yes | Gutter X Slope (%) | 1.2 |
| | | | No | Curb Slope (%) | 20.2 |

**Remove & Replace Curb Ramp With Two New Directional Ramps or Equivalent. Remove & Replace Gutter.**
