## Access Compliance Report Public Rights-of-Way (Curb Ramps)

Intersection ID: 46812 Main Street: ARBOR\_VISTA\_DR Cross Street: ADLIN\_AV Location: E

ADA ID: 43E0942141FA Ramp Type: PerpDiag Initial Pass/Fail: Fail Overall Compliance: No Severity Score: 22.5

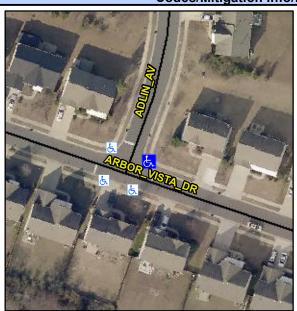
Not Found, R304.5.1, R304.2.2, R304.5.3

Field Measurements/Component Compnance					
Compliance Description D			Compliance Description		Data
N/A	Ramp Length (in)	47.0	No	Ramp Slope (%)	11.0
No	Ramp Width (in)	38.0	No	Ramp XSlope (%)	2.6
N/A	Flare Type LT	N/A	N/A	Flare Type RT	N/A
N/A	Flare Slope LT (%)	N/A	N/A	Flare Slope RT (%)	N/A
N/A	Flare Traversable LT?	N/A	N/A	Flare Traversable RT?	N/A
N/A	Landing Length (in)	N/A	N/A	DWS Provided?	N/A
N/A	Landing Width (in)	N/A	N/A	DWS Contrast?	N/A
N/A	Landing Slope (%)	N/A	N/A	DWS Length (in)	N/A
N/A	Landing X Slope (%)	N/A	N/A	DWS Full Width?	N/A
N/A	Landing Curb? (Y/N)	N/A	N/A	DWS Offset (in)	N/A
N/A	Shared Landing?	N/A			
N/A	Gutter Ponding?	N/A	N/A	Gutter Slope (%)	N/A
N/A	Gutter Lip Ht (in)	N/A	N/A	Gutter X Slope (%)	N/A
N/A	Painted X Walk1?	No	N/A	Painted X Walk2?	No
	X Walk 1 Direction	To NW		X Walk 2 Direction	To SW
N/A	X Walk 1 Width (in)	N/A	N/A	X Walk 2 Width (in)	N/A
	X Walk 1 Slope (%)	1.9		X Walk 2 Slope (%)	1.1

X Walk 1 X Slope (%)	4.0		X Walk 2 X Slope (%)	1.2
N/A	Ramp inside XWalk1?	N/A	N/A	Ramp inside XWalk2?	N/A
	Road Slope (%)	4.2	N/A	Clear Space?	N/A
	Road X Slope (%)	0.6	N/A	Clear Space to XWalk (in)	N/A
N/A	Any Obstructions?	N/A	N/A	Storm Grate/Utility Hazard?	N/A
	Obstruction Type		l	Storm Grate/Utility Type	
		N/A			N/A
			Yes	Surface Condition? (G/P)	Good

Remove & Replace Curb Ramp With Two New Directional Ramps or Equivalent.
