# Access Compliance Report

## Public Rights-of-Way

| Intersection ID: 11745 | Main Street: E_19TH_ST | Cross Street: HARRILL_ST | Location: W |
| ADA ID: 43F472CF9FF1 | Ramp Type: BlendTrans1 | Initial Pass/Fail: Fail | Overall Compliance: No |

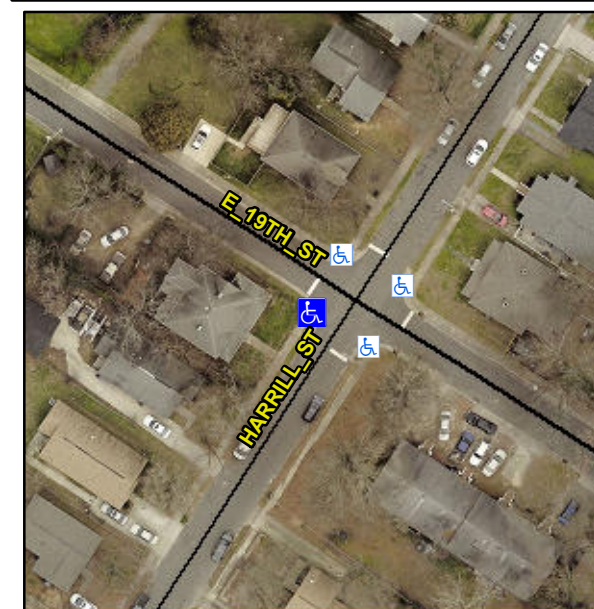
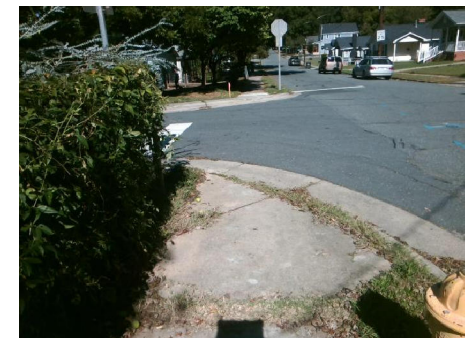
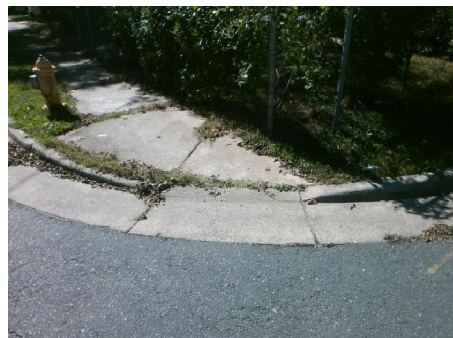
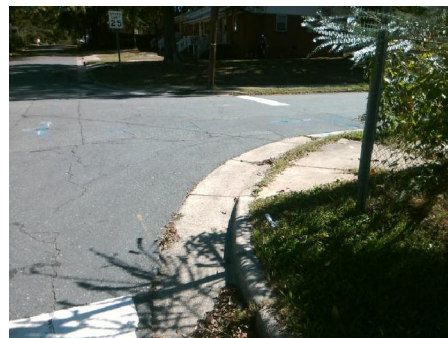
**VEGETATION OVERGROWTH, RP < 5%**

**Not Found, R304.5.1, R304.5.3**

| Compliance | Description | Data | Compliance | Description | Data |
|---|---|---|---|---|---|
| No | Ramp Width (in) | 36.0 | No | BlendTrans XSlope (%) | 5.0 |
| | | | No | Curb Slope (%) | 17.2 |

**Remove & Replace Curb Ramp With Two New Directional Ramps or Equivalent.**
