Access Compliance Report

Public Rights-of-Way

(Curb Ramps)

| Intersection ID: 12581 | Main Street: GLENSTAR_TR | Cross Street: SUDBURY_RD | Location: E |

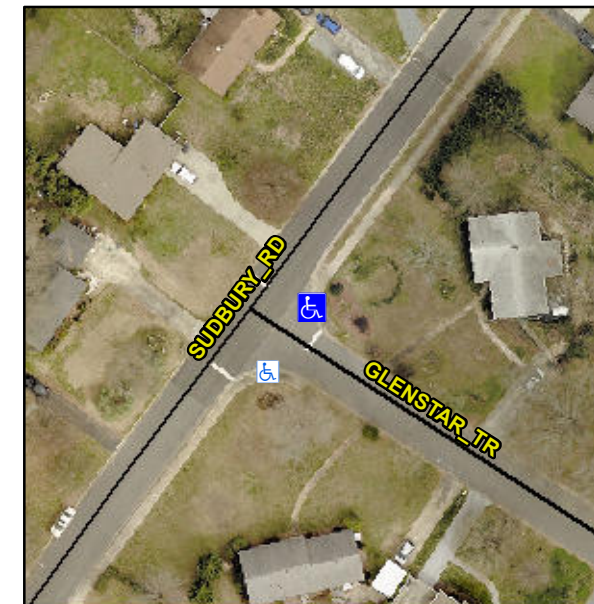
Not Found, R304.5.1

| Compliance | Description | Data | Compliance | Description | Data |
|---|---|---|---|---|---|
| No | Ramp Width (in) | 45.5 | Yes | Ramp XSlope (%) | 1.4 |

Remove & Replace Entire Ramp.
