Access Compliance Report Public Rights-of-Way (Curb Ramps)

Intersection ID: 27563 Main Street: BALLANTYNE_FOREST_DR Cross Street: LEDERER_AV Location:

Overall Compliance: No ADA ID: 441EAE436C1E Ramp Type: Perp Initial Pass/Fail: Fail Severity Score: 33.75

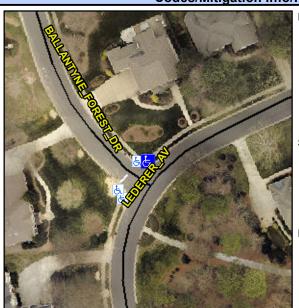
| Possible Solutions: | | | | | |
|---|--|--|--|--|--|
| Not Found, R304.5.1, R304.2.2, | | | | | |
| R304.5.3 | | | | | |

| Field Measurements/Component Compliance | | | | | | |
|---|---|---|---|---|---|--|
| N/A | Ramp Length (in) | 92.0 | No | Ramp Slope (%) | 9.2 | |
| No | Ramp Width (in) | 39.0 | No | Ramp XSlope (%) | 6.3 | |

| Possible Solutions: | | | | | |
|---|--|--|--|--|--|
| Remove & Replace Entire Ramp. | | | | | |
