Access Compliance Report Public Rights-of-Way (Curb Ramps)

Intersection ID: N/A Main Street: FRYE_PL Cross Street: N/A Location: N

ADA ID: 44A68BE35613 Ramp Type: Perp Initial Pass/Fail: Fail Overall Compliance: No Severity Score: 21.25

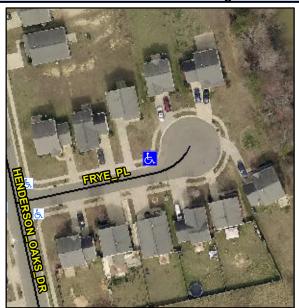
Comp	liance Description	Data	Comp	liance	Description	Data
N/A	Ramp Length (in)	7.0	No	Ramp	Slope (%)	9.5
No	Ramp Width (in)	36.0	Yes	Ramp	XSlope (%)	1.7
N/A	Flare Type LT	N/A	N/A	Flare	Type RT	N/A
N/A	Flare Slope LT (%)	N/A	N/A	Flare	Slope RT (%)	N/A
N/A	Flare Traversable LT?	N/A	N/A	Flare	Traversable RT?	N/A
N/A	Landing Length (in)	N/A	N/A	DWS	Provided?	N/A
N/A	Landing Width (in)	N/A	N/A	DWS	Contrast?	N/A
N/A	Landing Slope (%)	N/A	N/A	DWS	Length (in)	N/A
N/A	Landing X Slope (%)	N/A	N/A	DWS	Full Width?	N/A
N/A	Landing Curb? (Y/N)	N/A	N/A	DWS	Offset (in)	N/A
N/A	Shared Landing?	N/A				
N/A	Gutter Ponding?	N/A	N/A	Gutte	r Slope (%)	N/A
N/A	Gutter Lip Ht (in)	N/A	N/A	Gutte	r X Slope (%)	N/A
N/A	Painted X Walk1?	No	N/A	Paint	ed X Walk2?	N/A
	X Walk 1 Direction	To S		X Wa	lk 2 Direction	N/A
N/A	X Walk 1 Width (in)	N/A	N/A	X Wa	lk 2 Width (in)	N/A
	X Walk 1 Slope (%)	1.4		X Wa	lk 2 Slope (%)	N/A
	X Walk 1 X Slope (%)	0.9		X Wa	lk 2 X Slope (%)	N/A

OSSIDIE SOIULIOII	
Possible Solutions:	Co
Remove & Replace Entire Ramp.	
·	No
	N/A
	N/
	N/
	N/
Surveyor Notes:	N/
N/A	N/
	N/
	N/
	N/
PROW/ADA:	N/
Not Found, R304.5.1, R304.2.2	N/A
	N/
	N/.
	N/.
