Access Compliance Report

Public Rights-of-Way

Intersection ID: 14278	Main Street: ROMARE_BEARDEN_DR	Cross Street: FARMER_ST	Location: W
ADA ID: 44E53FBE7456	Ramp Type: MedianPerp	Initial Pass/Fail: Fail	Overall Compliance: No
Severity Score: 1.25			
Codes/Mitigation Info/Possible Solution		Field Measurements/Component Compliance

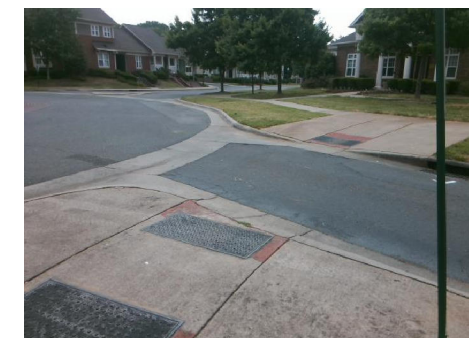
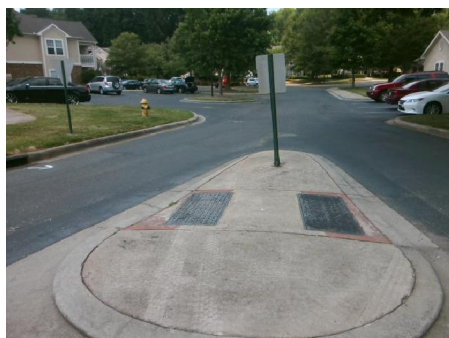
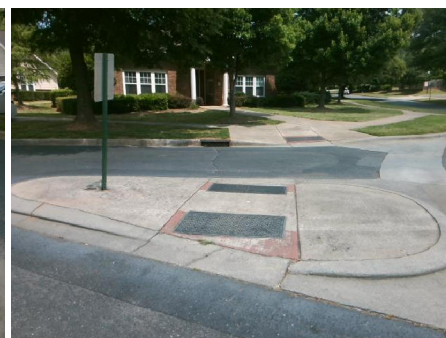
Not Found, R304.5.3

Compliance	Description	Data	Compliance	Description	Data
N/A	Ramp Length (in)	43.0	Yes	Ramp Slope (%)	6.4
Yes	Ramp Width (in)	58.0	No	Ramp XSlope (%)	3.0
N/A	Flare Type LT	N/A	N/A	Flare Type RT	N/A
N/A	Flare Slope LT (%)	N/A	N/A	Flare Slope RT (%)	N/A
N/A	Flare Traversable LT?	N/A	N/A	Flare Traversable RT?	N/A
N/A	Landing Length (in)	N/A	N/A	DWS Provided?	N/A
N/A	Landing Width (in)	N/A	N/A	DWS Contrast?	N/A
N/A	Landing Slope (%)	N/A	N/A	DWS Length (in)	N/A
N/A	Landing X Slope (%)	N/A	N/A	DWS Full Width?	N/A
N/A	Landing Curb? (Y/N)	N/A	N/A	DWS Offset (in)	N/A
N/A	Shared Landing?	N/A			
N/A	Gutter Ponding?	N/A	N/A	Gutter Slope (%)	N/A
N/A	Gutter Lip Ht (in)	N/A	N/A	Gutter X Slope (%)	N/A
N/A	Painted X Walk1?	No	N/A	Painted X Walk2?	N/A
	X Walk 1 Direction	To S		X Walk 2 Direction	N/A
N/A	X Walk 1 Width (in)	N/A	N/A	X Walk 2 Width (in)	N/A
	X Walk 1 Slope (%)	0.6		X Walk 2 Slope (%)	N/A
	X Walk 1 X Slope (%)	0.5		X Walk 2 X Slope (%)	N/A

Remove & Replace Entire Ramp.
