Access Compliance Report

Public Rights-of-Way

(Curb Ramps)

Intersection ID: 49791	Main Street: BAHIA_LN	Cross Street: BARLEY_LN	Location: SE
ADA ID: 457E2379405A	Ramp Type: Perp	Initial Pass/Fail: Fail	Overall Compliance: No
Severity Score: 10			
Codes/Mitigation Info/Possible Solution		Field Measurements/Component Compliance

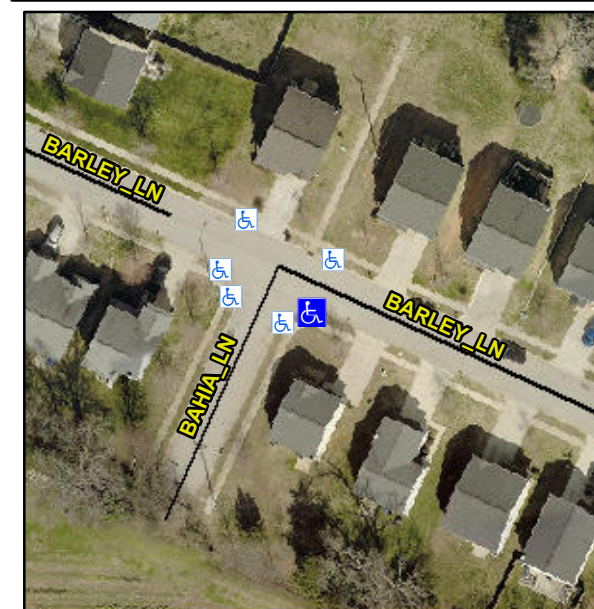
Not Found, R304.5.1

Compliance	Description	Data	Compliance	Description	Data
N/A	Ramp Length (in)	48.0	Yes	Ramp Slope (%)	6.0
No	Ramp Width (in)	47.0	Yes	Ramp XSlope (%)	3.3
N/A	Flare Type LT	N/A	N/A	Flare Type RT	N/A
N/A	Flare Slope LT (%)	N/A	N/A	Flare Slope RT (%)	N/A
N/A	Flare Traversable LT?	N/A	N/A	Flare Traversable RT?	N/A
N/A	Landing Length (in)	N/A	N/A	DWS Provided?	N/A
N/A	Landing Width (in)	N/A	N/A	DWS Contrast?	N/A
N/A	Landing Slope (%)	N/A	N/A	DWS Length (in)	N/A
N/A	Landing X Slope (%)	N/A	N/A	DWS Full Width?	N/A
N/A	Landing Curb? (Y/N)	N/A	N/A	DWS Offset (in)	N/A
N/A	Shared Landing?	N/A			
N/A	Gutter Ponding?	N/A	N/A	Gutter Slope (%)	N/A
N/A	Gutter Lip Ht (in)	N/A	N/A	Gutter X Slope (%)	N/A
N/A	Painted X Walk1?	No	N/A	Painted X Walk2?	N/A
	X Walk 1 Direction	To NE		X Walk 2 Direction	N/A
N/A	X Walk 1 Width (in)	N/A	N/A	X Walk 2 Width (in)	N/A
	X Walk 1 Slope (%)	3.0		X Walk 2 Slope (%)	N/A
	X Walk 1 X Slope (%)	4.2		X Walk 2 X Slope (%)	N/A

N/A	Ramp inside XWalk1?	N/A	N/A	Ramp inside XWalk2?	N/A
	Road Slope (%)	N/A	N/A	Clear Space?	N/A
	Road X Slope (%)	N/A	N/A	Clear Space to XWalk (in)	N/A
N/A	Any Obstructions?	N/A	N/A	Storm Grate/Utility Hazard?	N/A
	Obstruction Type			Storm Grate/Utility Type	
		N/A			N/A
			Yes	Surface Condition? (G/P)	Good

Remove & Replace Entire Ramp.
