# Access Compliance Report

## Public Rights-of-Way

### (Curb Ramps)

| Intersection ID: 49791 | Main Street: BAHIA_LN | Cross Street: BARLEY_LN | Location: | N |

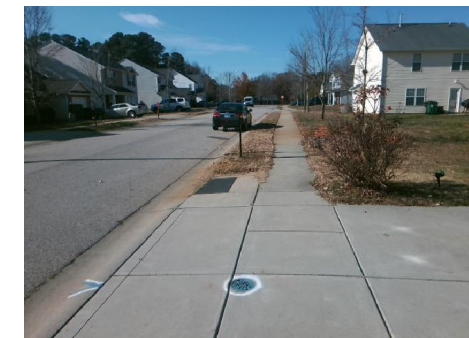
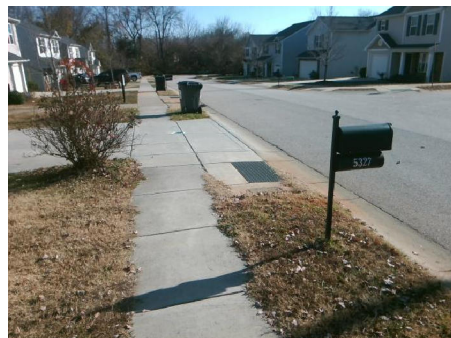
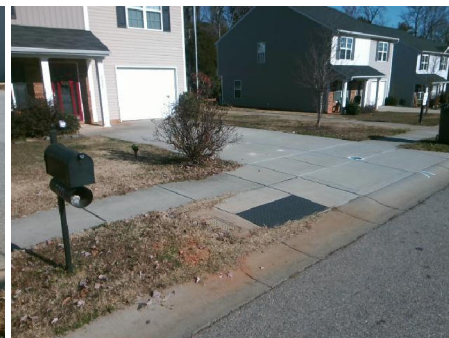
**Not Found, R304.5.3, R304.2.1,  
R304.2.2-Perp, R304.3.2-Para**

| Compliance | Description | Data | Compliance | Description | Data |
|---|---|---|---|---|---|
| Yes | Ramp Width (in) | 48.0 | No | Ramp XSlope (%) | 2.6 |
| No | Landing Length (in) | 25.0 | Yes | DWS Provided? | Yes |
| No | Landing Width (in) | 47.5 | Yes | DWS Contrast? | Yes |
| No | Landing Slope (%) | 4.7 | Yes | DWS Length (in) | 24.0 |
| No | Landing X Slope (%) | 3.1 | Yes | DWS Full Width? | Yes |
| Yes | Gutter Lip Ht (in) | 0.0 | No | Gutter X Slope (%) | 2.9 |

**Remove & Replace Entire Ramp.  
Remove & Replace Gutter.**
