Access Compliance Report

Public Rights-of-Way

(Curb Ramps)

Intersection ID: 11552	Main Street: ANNE_ST	Cross Street: CHERYL_ST	Location: NW
ADA ID: 45CEB2E31C5F	Ramp Type: Combination2Diag	Initial Pass/Fail: Fail	Overall Compliance: No
		Severity Score: 0

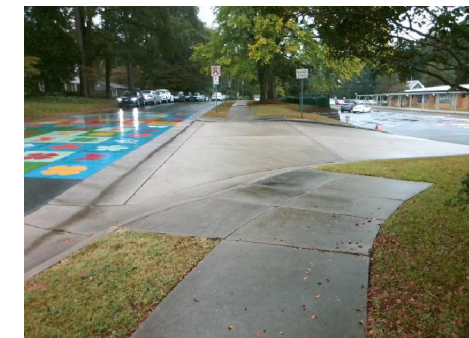
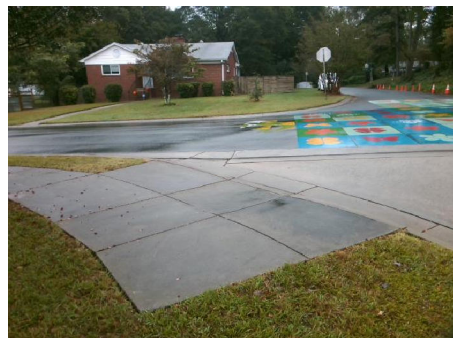
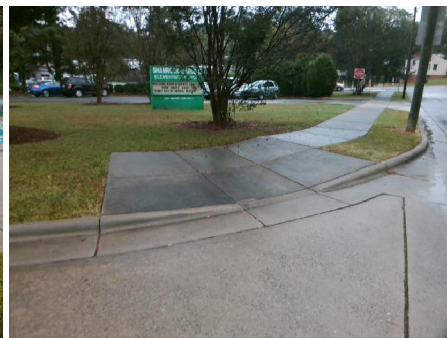
Compliance	Description	Data	Compliance	Description	Data
N/A	Ramp Length LT (in)	N/A	N/A	Ramp Length RT (in)	51.0
N/A	Ramp Width LT (in)	N/A	Yes	Ramp Width RT (in)	59.0
N/A	Ramp Slope LT (%)	N/A	No	Ramp Slope RT (%)	9.6
N/A	Ramp XSlope LT (%)	N/A	No	Ramp XSlope RT (%)	2.9
N/A	Ramp Length (in)	54.0	Yes	Ramp Slope (%)	5.5
No	Ramp Width (in)	46.0	No	Ramp XSlope (%)	3.5
N/A	Flare Type LT	N/A	N/A	Flare Type RT	N/A
N/A	Flare Slope LT (%)	N/A	N/A	Flare Slope RT (%)	N/A
N/A	Flare Traversable LT?	N/A	N/A	Flare Traversable RT?	N/A
N/A	Landing Length (in)	N/A	N/A	DWS Provided?	N/A
N/A	Landing Width (in)	N/A	N/A	DWS Contrast?	N/A
N/A	Landing Slope (%)	N/A	N/A	DWS Length (in)	N/A
N/A	Landing X Slope (%)	N/A	N/A	DWS Full Width?	N/A
N/A	Landing Curb? (Y/N)	N/A	N/A	DWS Offset (in)	N/A
N/A	Shared Landing?	N/A			
N/A	Gutter Ponding?	N/A	N/A	Gutter Slope (%)	N/A
N/A	Gutter Lip Ht (in)	N/A	N/A	Gutter X Slope (%)	N/A
N/A	Painted X Walk1?	No	N/A	Painted X Walk2?	No

X Walk 1 Direction	To S		X Walk 2 Direction	To E
	X Walk 1 Width (in)	N/A		X Walk 2 Width (in)	N/A
	X Walk 1 Slope (%)	6.1		X Walk 2 Slope (%)	6.5
	X Walk 1 X Slope (%)	9.6		X Walk 2 X Slope (%)	4.3
N/A	Ramp inside XWalk1?	N/A	N/A	Ramp inside XWalk2?	N/A
	Road Slope (%)	1.2		Clear Space?	N/A
	Road X Slope (%)	9.3	N/A	Clear Space to XWalk (in)	N/A
			N/A	Any Obstruction?	N/A
				Obstruction Type	N/A
			N/A	Storm Grate/Utility Hazard?	N/A
				Storm Grate/Utility Type	N/A
Yes	Surface Condition? (G/P)	Good			
	Curb Slope (%)	0.3

Remove & Replace Curb Ramp With Two New Directional Ramps or Equivalent.
