Access Compliance Report

Public Rights-of-Way

(Curb Ramps)

Intersection ID: 12833	Main Street: HICKORY GROVE RD	Cross Street: VALLEYVIEW DR	Location: SE
ADA ID: 4614F8461CDB	Ramp Type: Combination1	Initial Pass/Fail: Fail	Overall Compliance: No
		Severity Score: 10

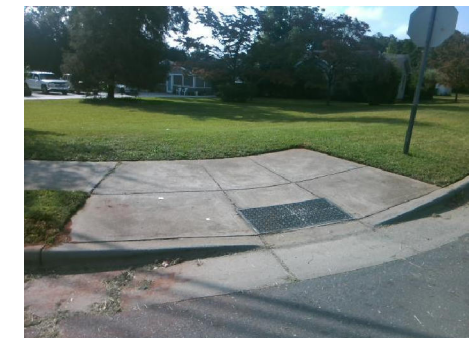
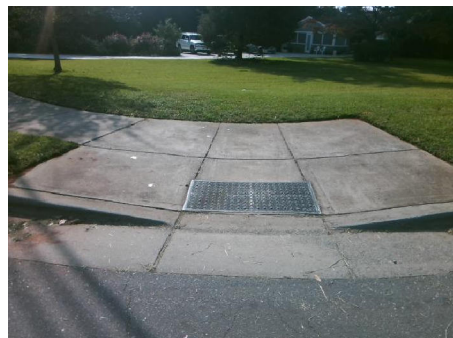
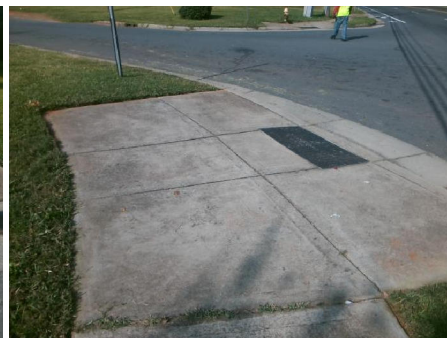
LT RP < 5%

Not Found, R304.5.1, R304.5.3

Remove & Replace Entire Ramp.
